Landslides in Colorado, USA: Impacts and Loss Estimation for the Year 2010

By Lynn M. Highland

Open-File Report 2012–xxxx

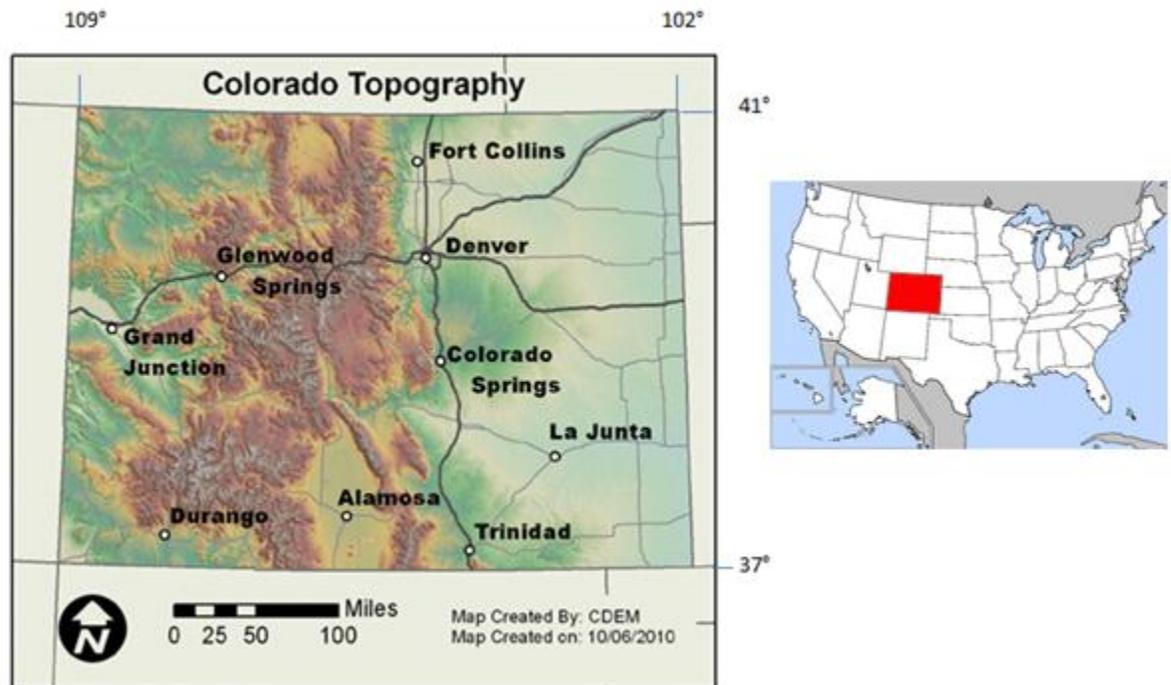
Figure 1. Map of Colorado topography, showing major roads and cities. Elevation is lowest in light-green-colored area and highest in brown- and gray-colored areas. Map is modified from a map found in the Colorado Division of Emergency Management report (2011).

Figure 1 shows the State of Colorado along with the locations of Colorado's largest cities and main highways. In order to get a broad understanding about landslide occurrence in

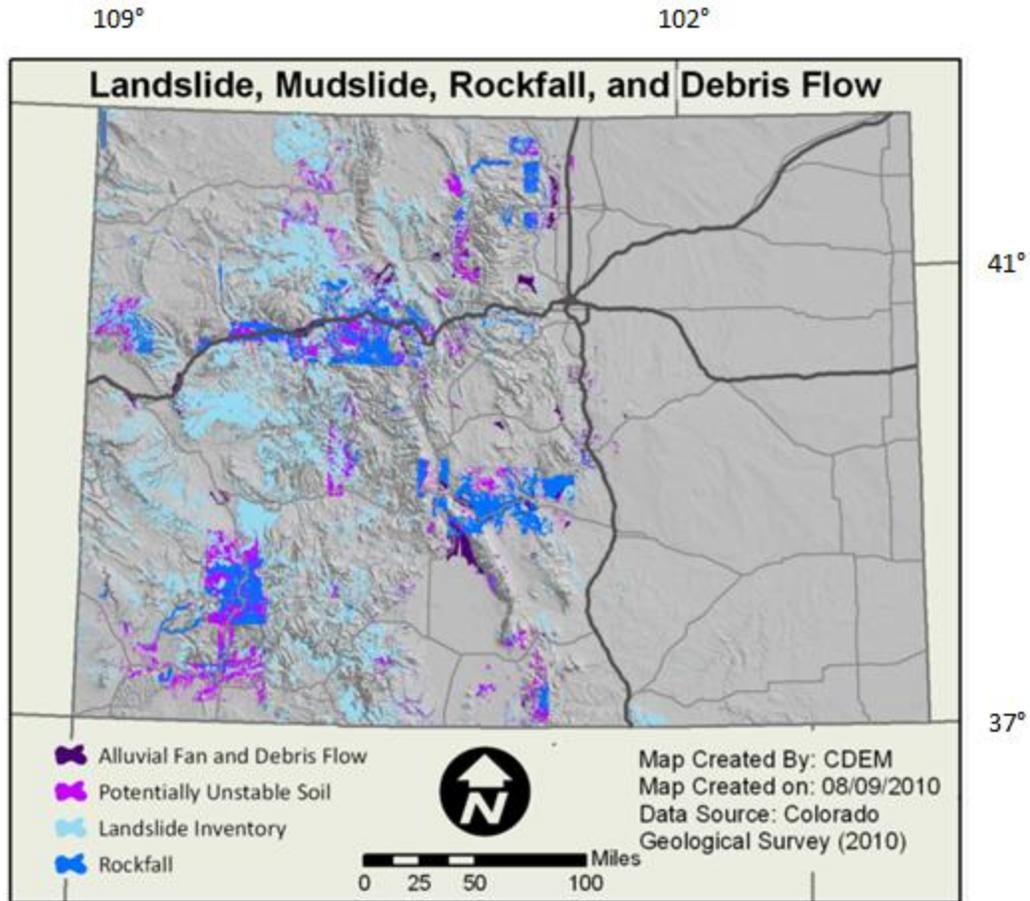
Figure 2. Map of alluvial fan and debris flow, potentially unstable soil, landslide inventory, and rockfall for Colorado. This map is modified from a map created by the Colorado Department of Emergency Management, using data from the Colorado Geological Survey (Colorado Division of Emergency Management, 2011).

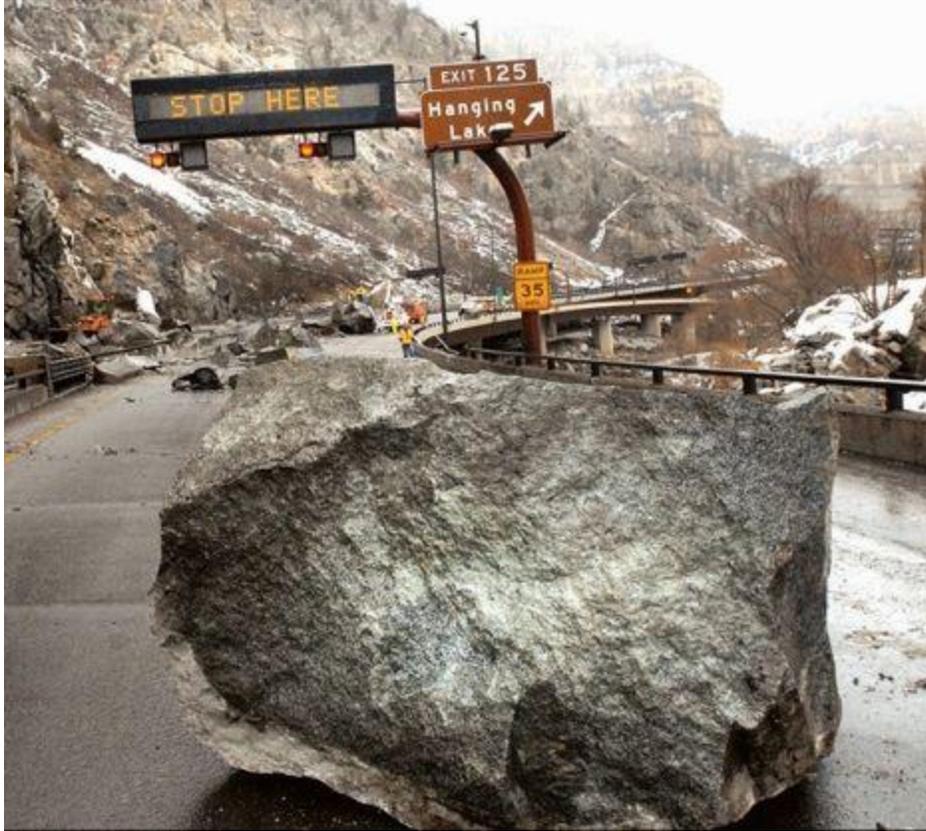
Figure 3. Interstate-70 in Glenwood Canyon, Colo. The March 8, 2010, rock slide closed the highway and damaged this elevated portion of Interstate-70. Photograph by Colorado Department of Transportation.

This rockfall occurred on March 8, 2010. It is estimated that at least 20 boulders fell onto Interstate-70, ranging in size from 1 to 3 meters (m) in diameter. The largest was estimated to have weighed about 66 tons. Figures 3 and 4 show damage caused by the rockfall. The rocks

made holes in the elevated sections of roadway, the largest being in the westbound lanes (closest to the hillside) and measuring 6.2×3.2 m. Another hole in the lower eastbound lanes measured 2×2 m. There were several other holes and craters in the roadway, as well as areas where rocks were embedded. Most of the areas that needed repair appeared to be approximately 3.6×3.6 m. Rocks were scattered over 100 m of roadway. Other rock-fall impacts included damage to three sections of steel guard rail and to sections of median barriers. This damage was similar to that from a 2004 rockfall. (Although this November 25, 2004, (Thanksgiving Day) rockfall was in the same general area, the rocks came from a different height on the slope.)

The 2010 repair work took place between mile markers 124 and 125, just west of Hanging Lake Tunnel. The work involved bridge deck and bridge wall/rail repairs (including 50 m, or 150 feet (ft), of new steel bridge rail); guardrail repairs (about 40 m or 120 ft) to the hillside concrete barrier; median concrete barrier repair (replacement of 133 m, (400 ft)); removal and replacement of 690 square feet (ft²) of concrete retaining walls; straightening of steel bridge girders; some lighting and electrical repairs; and repairs to the bike trail below. Finally, crews used approximately 500 tons of base course material on the roadway, as well as 400 tons of patching asphalt, to repair the driving surface.

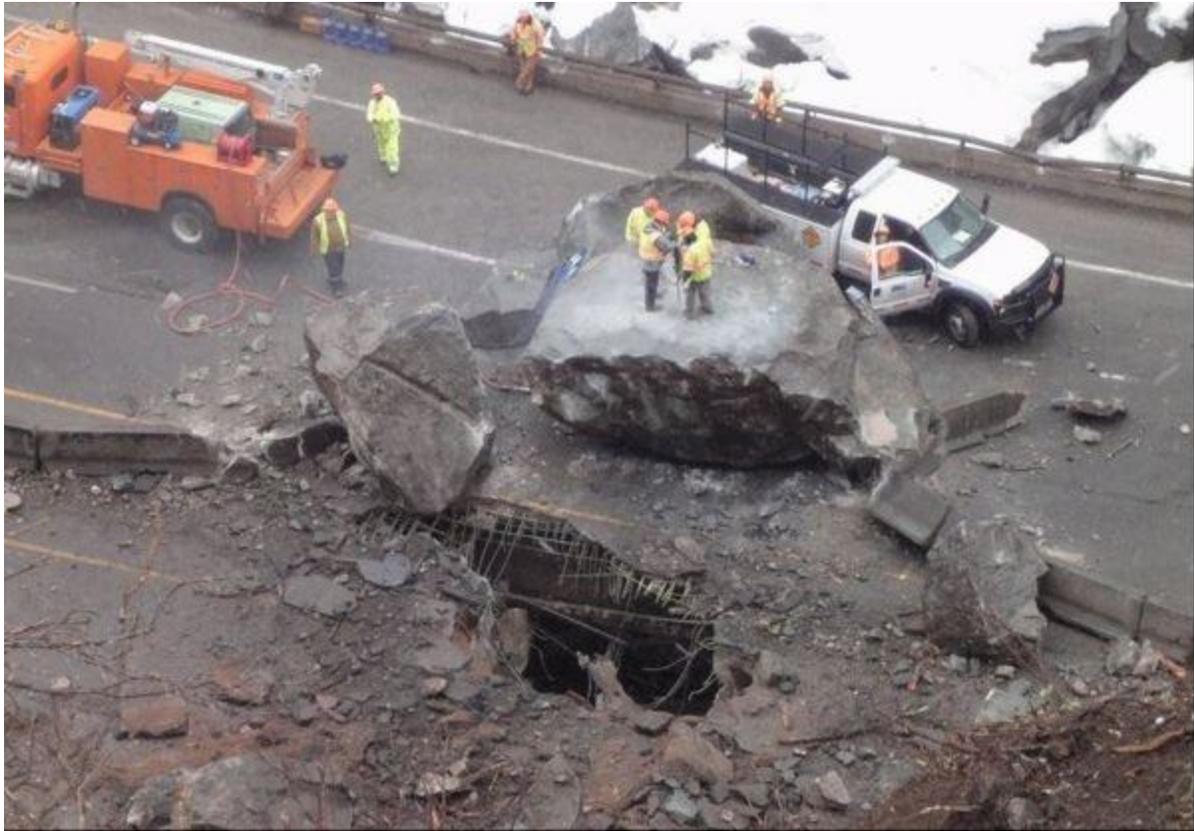
Figure 4. Photo showing an overview of the 2010 Glenwood Canyon, Colo., rockfall showing damage to the road deck on the elevated portion of Interstate-70. Photograph by Colorado Department of Transportation.

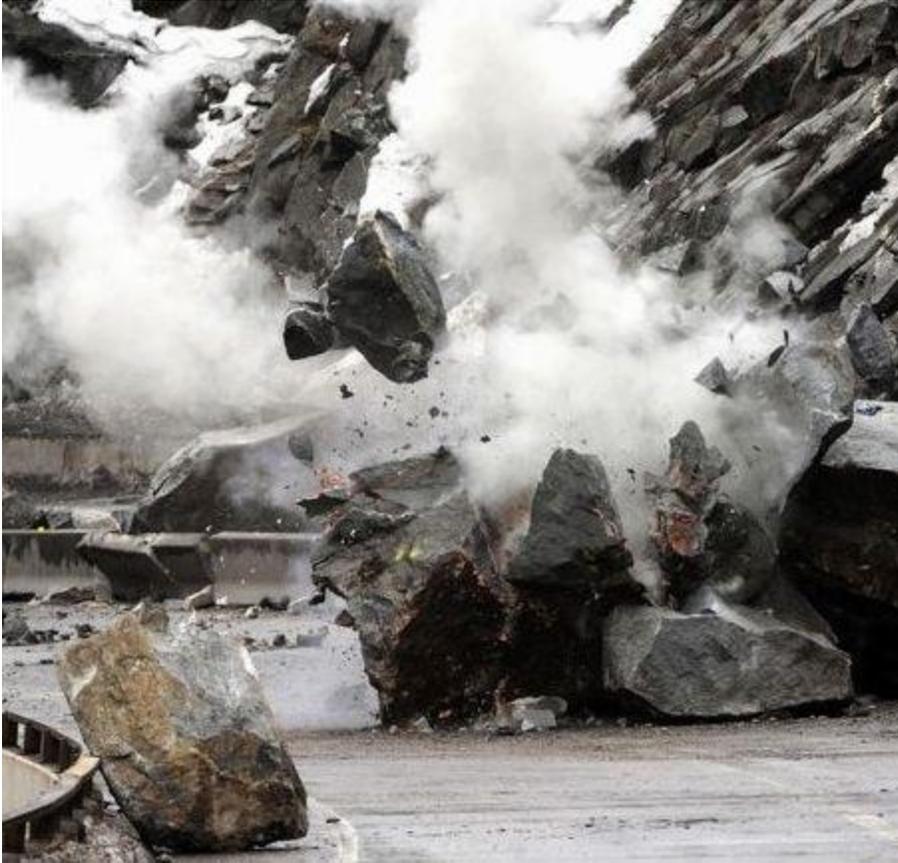
Figure 5. Rock-blasting by Colorado Department of Transportation (CDOT) after the March, 2010, Glenwood Canyon rockfall, on Interstate-70. These rocks were removed because they were precariously poised above the rockfall area, could endanger workers repairing the highway, and could possibly be a threat to the highway in the near future. Photograph by CDOT.

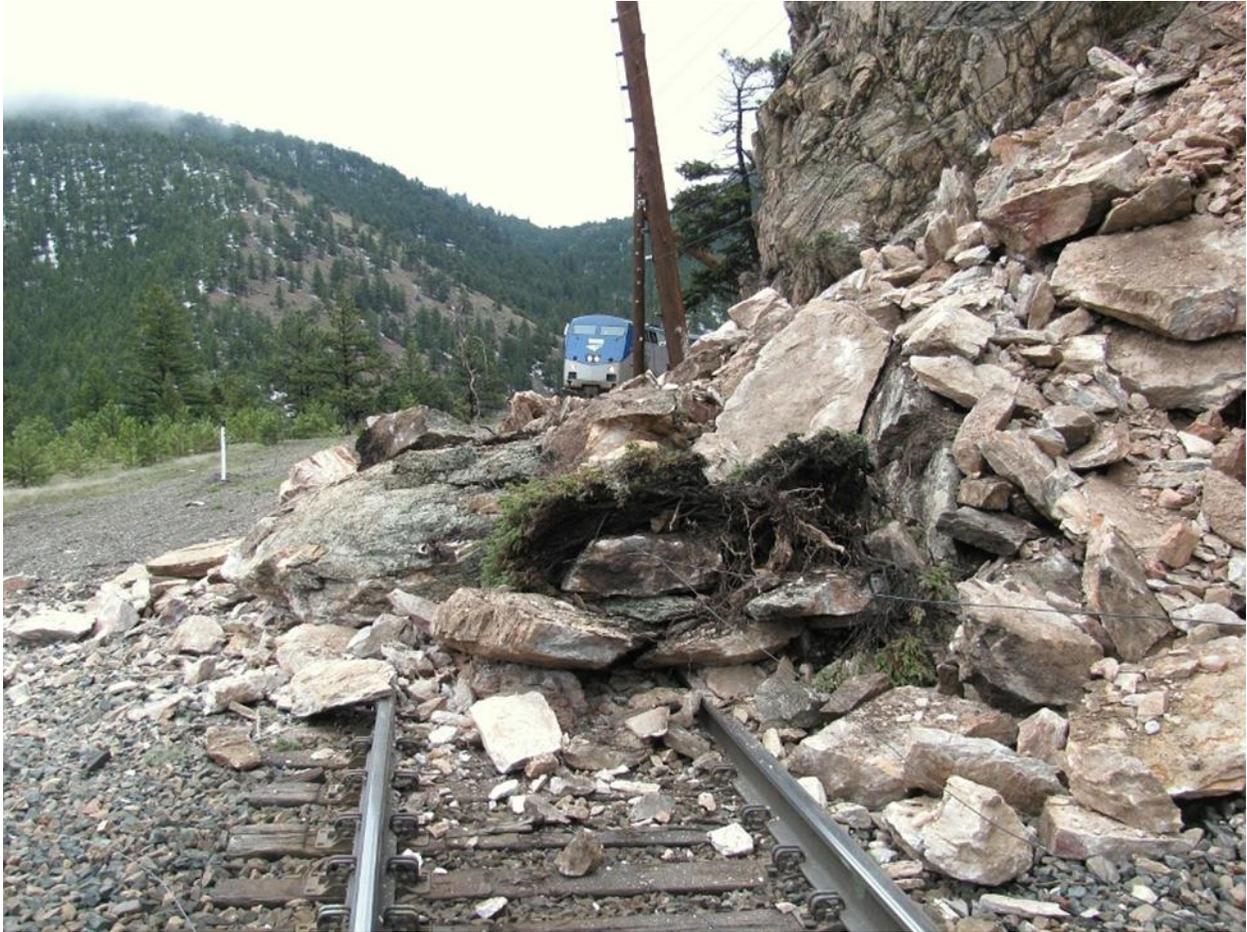
Figure 6. A photograph of the rock slide that blocked an Amtrak train on May 15, 2010. The train had to return to Denver, a distance of about 48 kilometers (30 miles). (Photo by "Rovertrain" on <http://www.Trainorders.com>)

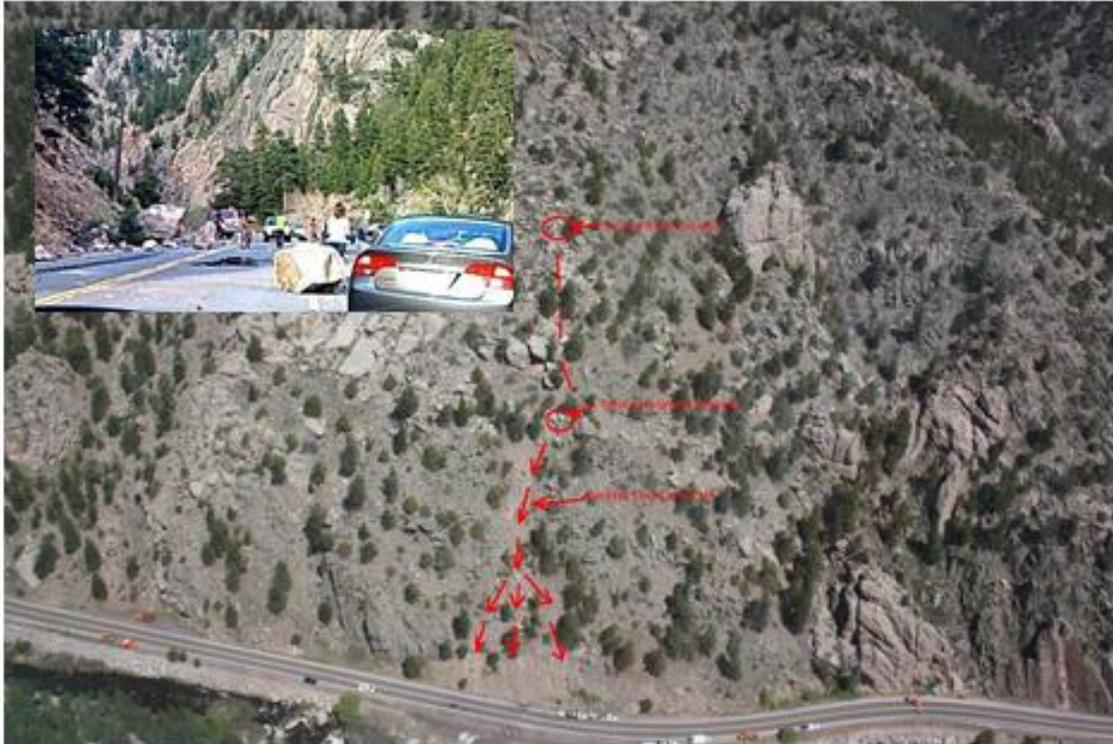
Figure 7. Photograph of the source area of the May 21, 2010, rockfall that impacted Highway 34 near Estes Park, Colo. Inset shows a road-level photograph of the area on the highway where rocks fell. Photograph and graphics courtesy of Tyler Ortiz, Colorado Department of Transportation.

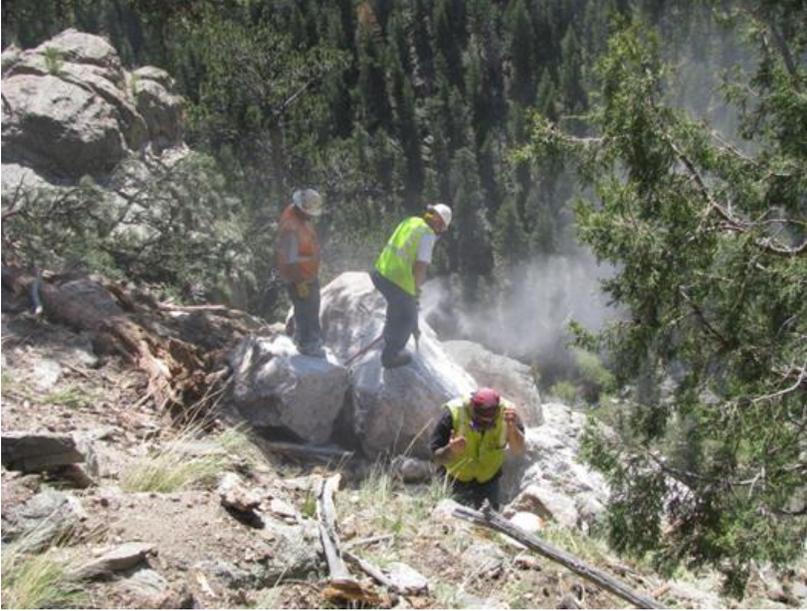
Figure 8. Colorado Department of Transportation (CDOT) crews breaking up rocks above the closed Highway 34 after the rockfall event of May 21, 2010, near Estes Park, Colo. The rock was brought down and hauled away to mitigate the rockfall hazard. Photograph courtesy of Tyler Ortiz, CDOT.

CDOT worked quickly to clear the road and repair damage, after closing the road on the evening of May 21. The State Patrol advised alternate routes through the canyon. CDOT crews began further mitigation activities by blasting and scaling loose rocks, bringing down about 500 cubic yards of material.

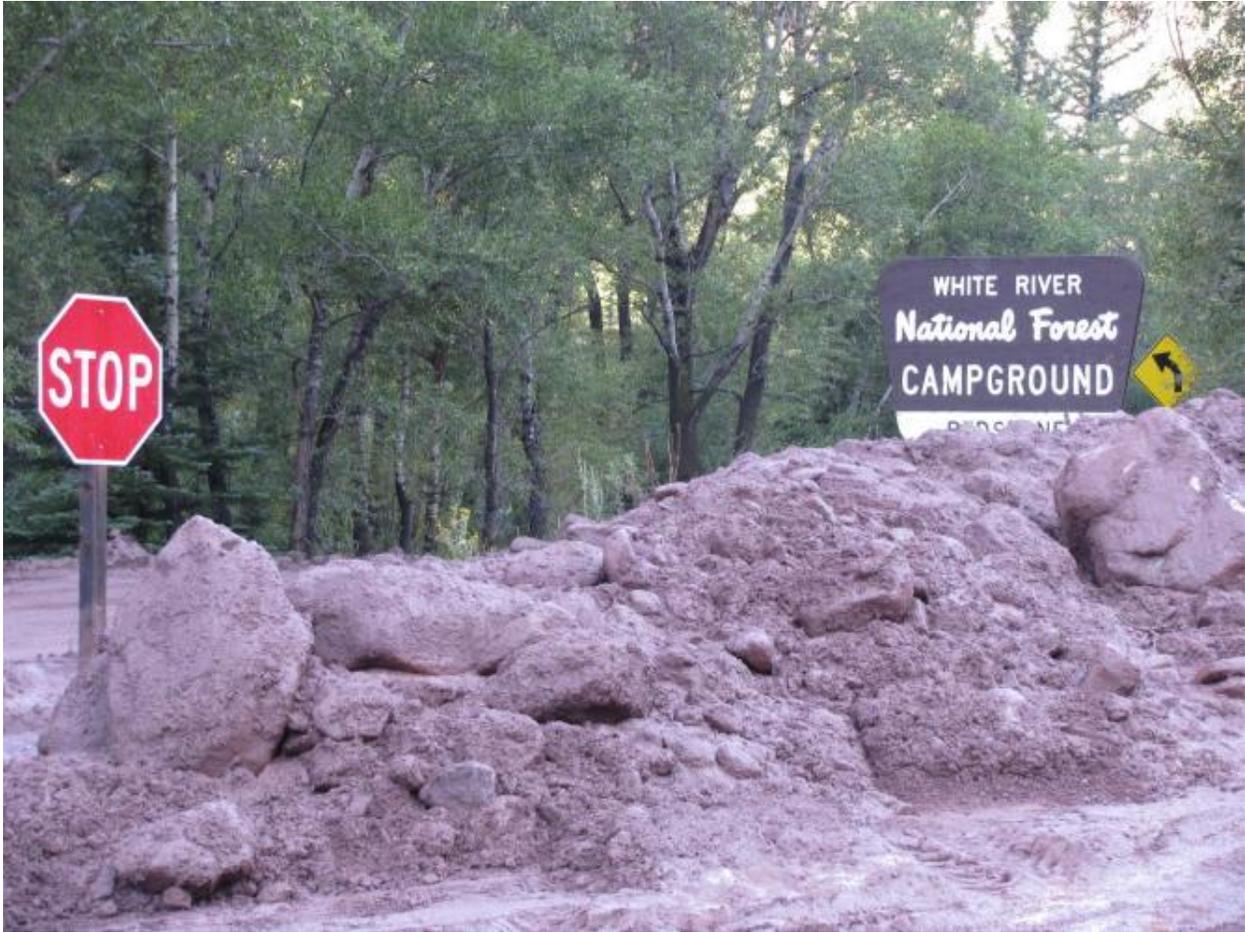
Figure 9. Redstone Campground inundated by mud, from the July 31, 2010 event. (Photo by Jeff Bier.)

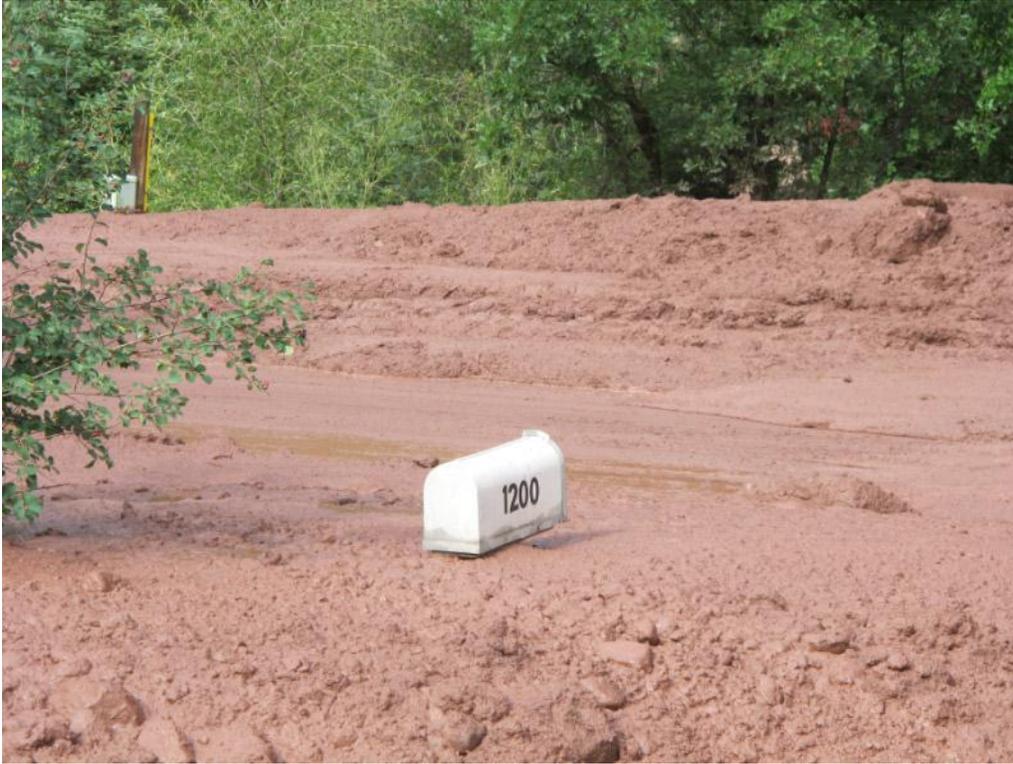
Figure 10. Deep mud from the debris-flow event of July 31, 2010, near a Redstone, Colo., campground. Photograph by Jeff Bier.

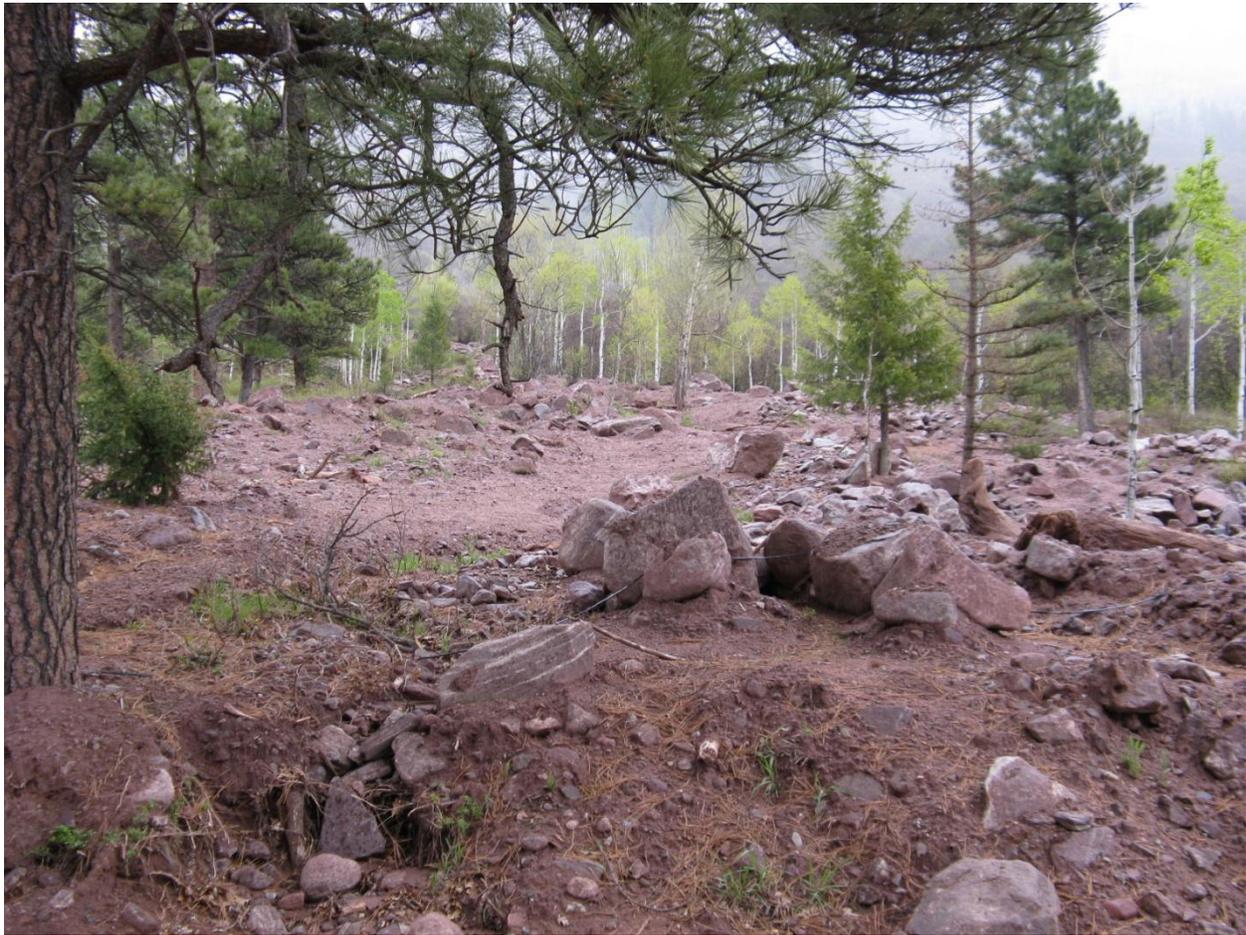
Figure 11. The Redstone Campground debris flows, 10 months after the event. There was one person missing and presumed dead, as a result of the debris flow in July, 2010. Photograph by Lynn Highland, USGS, taken on May 19, 2011.

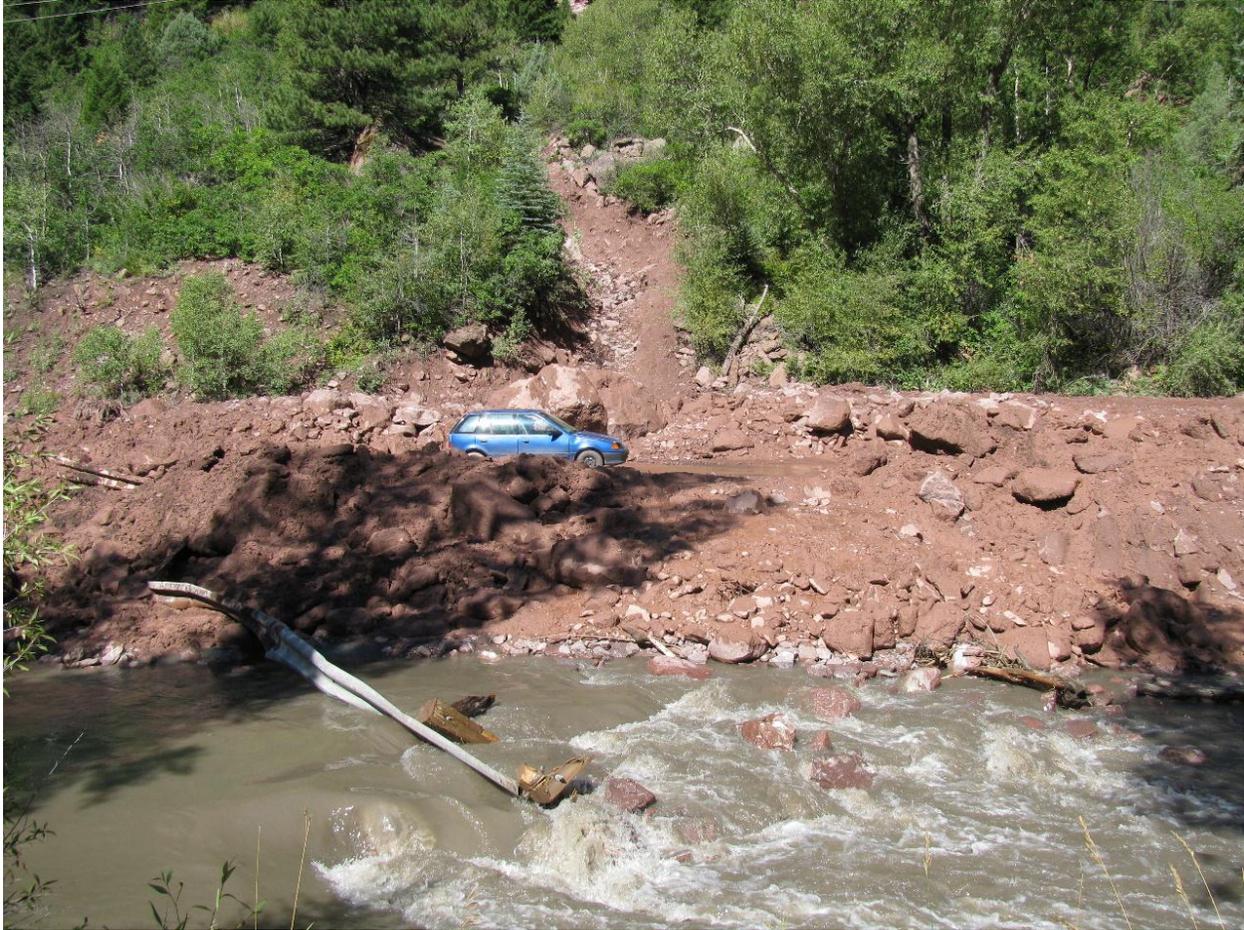
Figure 12. August 19, 2010. Highway 133 was closed at Redstone, Colo., for several hours, but crews were able to reopen one lane. There were six drainages where mud crossed Highway 133, taking out 100 feet (33.3 meters) of guardrail. The Crystal River (which flows parallel to Highway 133) is shown in the foreground. Photograph by Sue McEvoy.

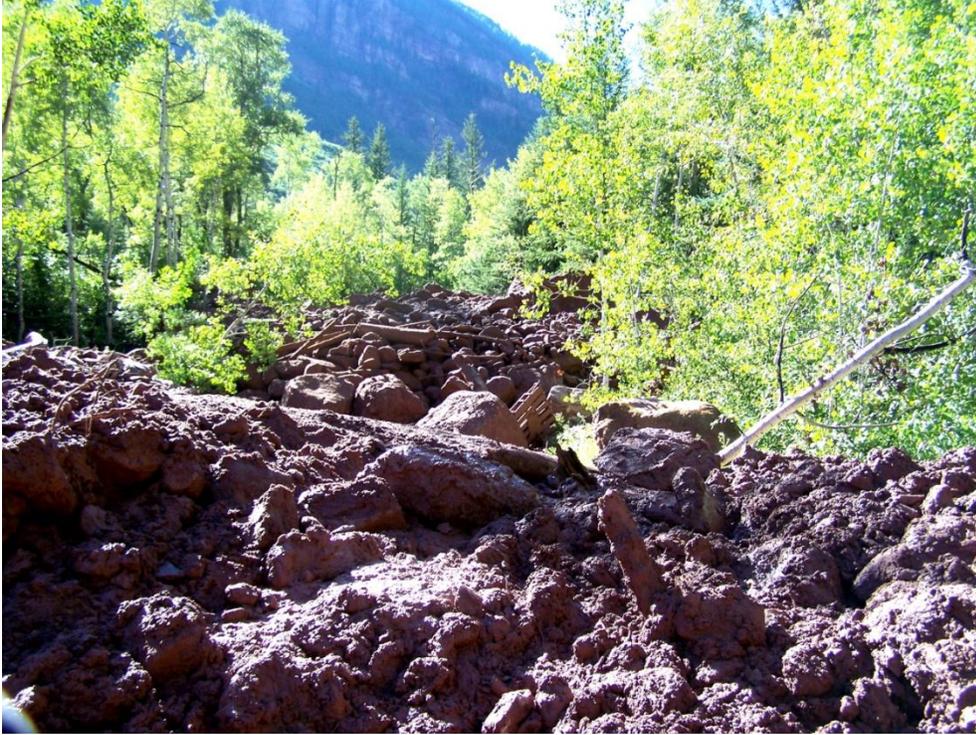
Figure 13. August 19, 2010. A photo of a debris flow on Katy Creek, on private property, near Redstone, Colo. Photograph is courtesy of Mary Dorais, property owner.

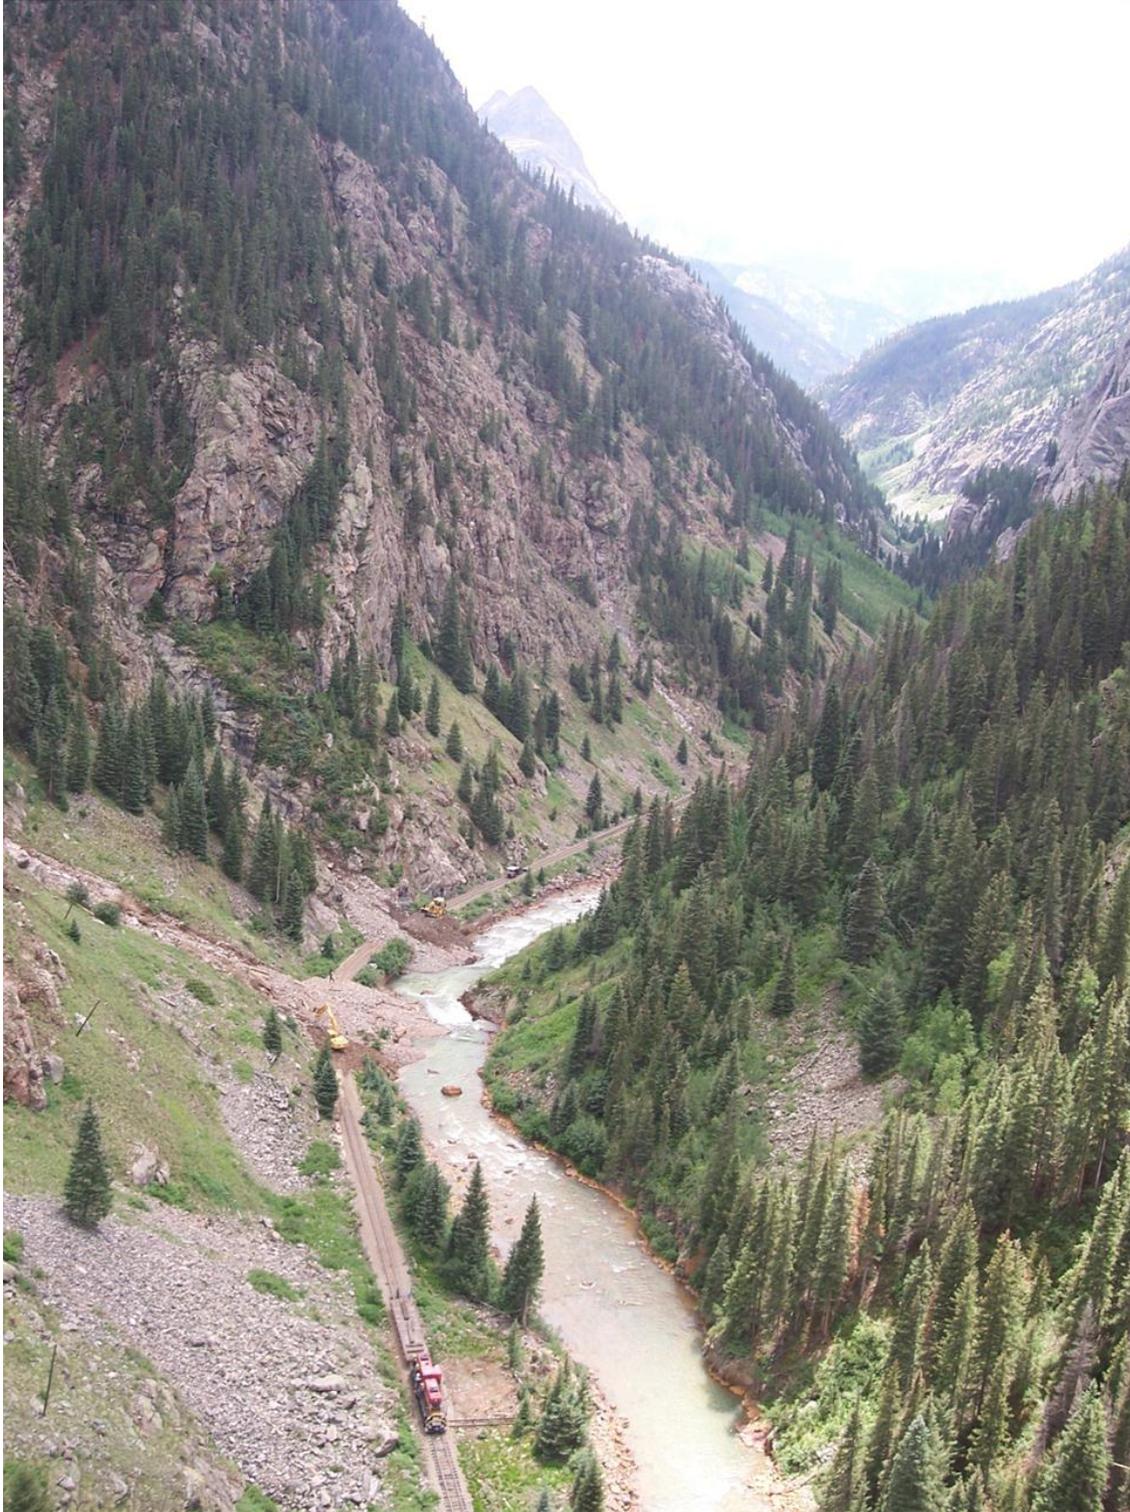
Figure 15. Aerial photograph of two debris flows that flowed over the Durango and Silverton Narrow Gauge Railroad—a scenic railroad company for tourists—that operates out of Durango, Colo. The photo was taken by a zipline participant as he was passing over the area. Photograph courtesy of Tall Timber Resort/Soaring Tree Top Adventures.

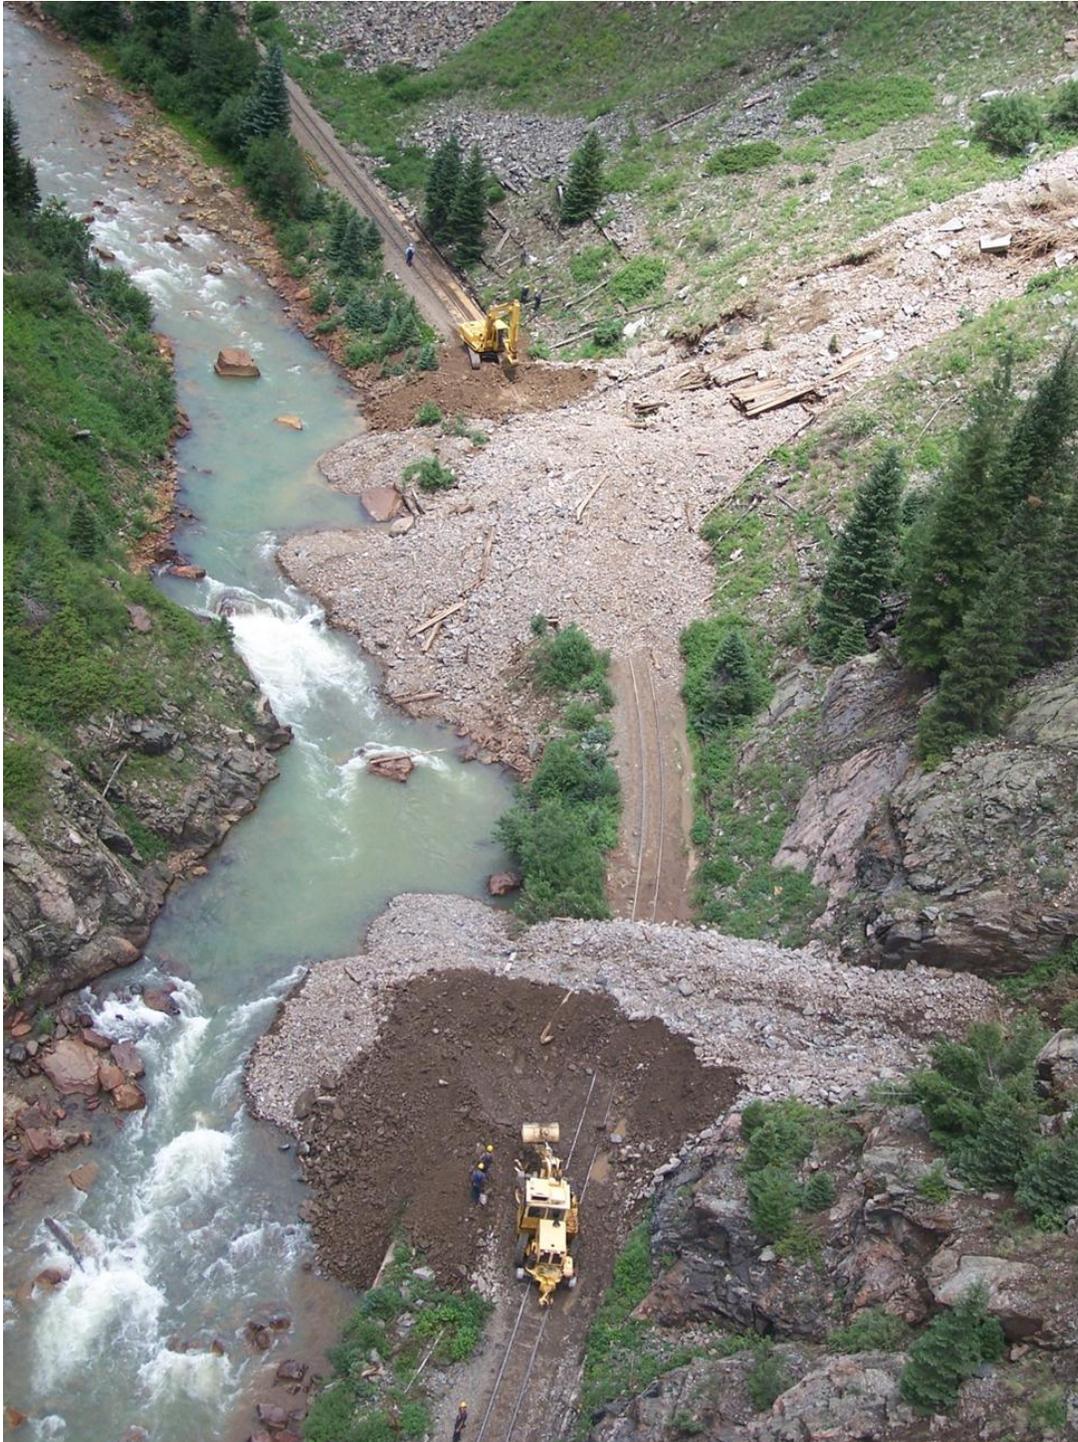
Figure 16. A close-up aerial view of the two debris flows that blocked the Durango Silverton Narrow Gauge Railroad track in July, 2010. Cleanup was performed by railroad crews. Photograph courtesy of Tall Timber Resort/Soaring Tree Top Adventures.

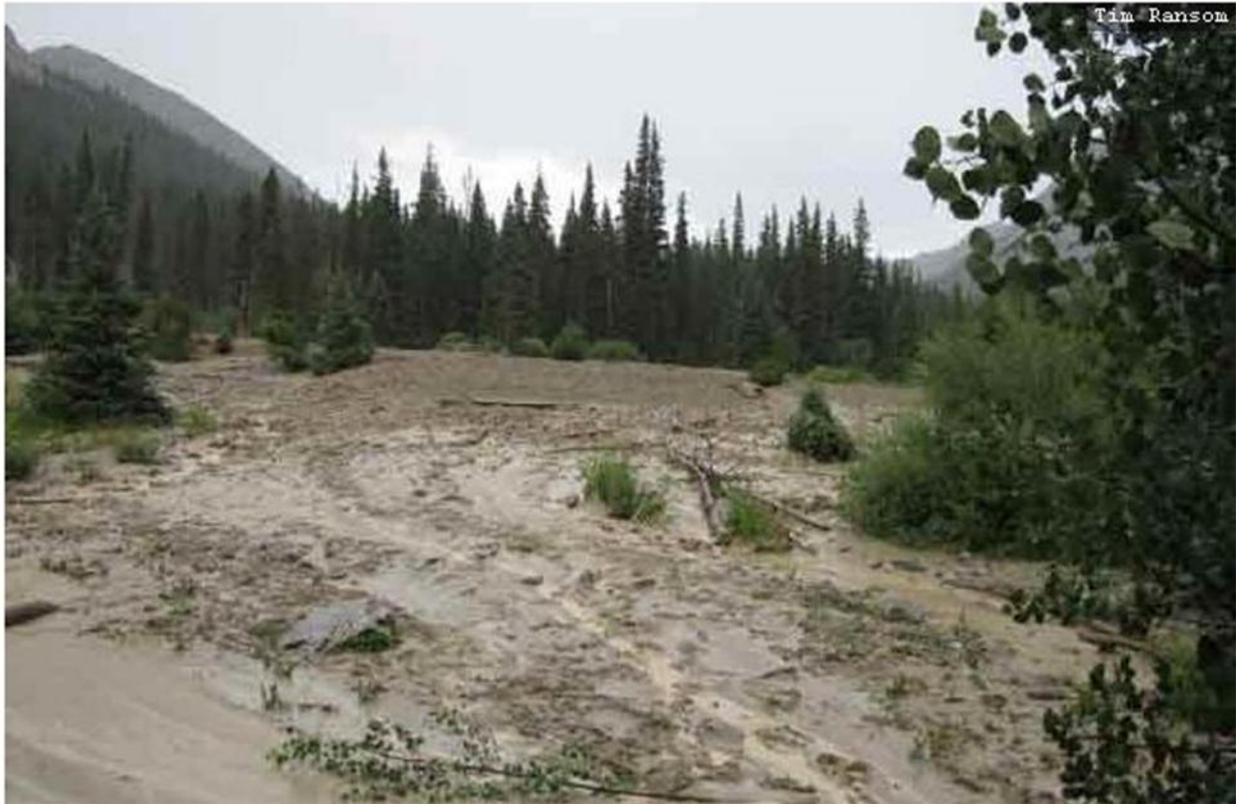
Figure 17. This debris flow occurred on July 31, 2010, in the San Isabel National Forest (near Leadville, Colo.). The area experienced 6 hours of heavy rain, which was thought to have triggered two large debris flows in the area. Photograph by Mary Widner.

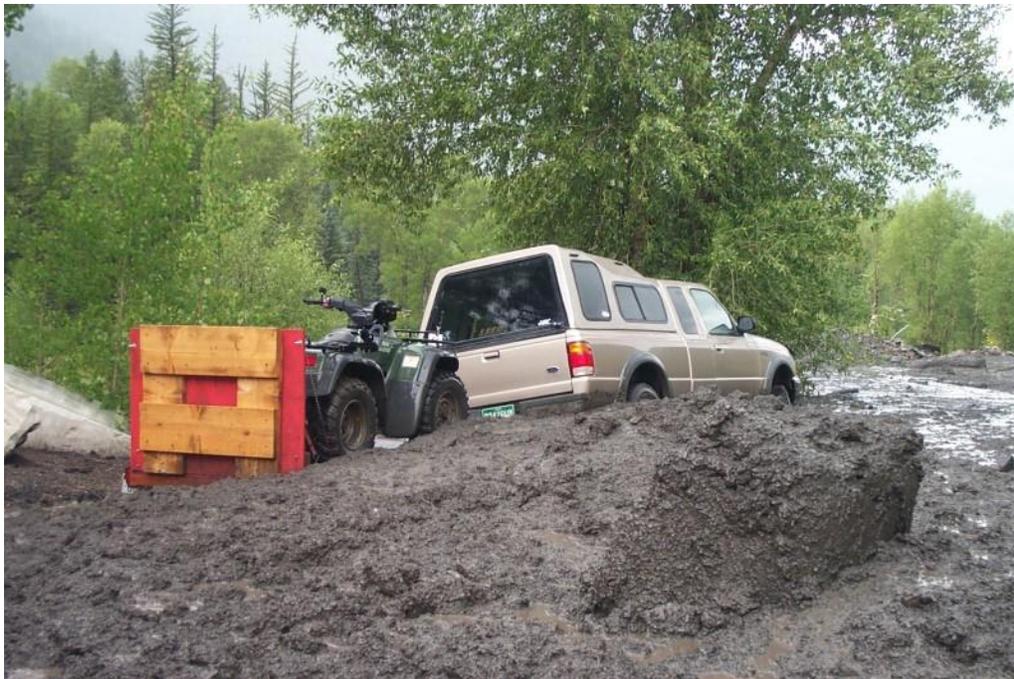
Figure 18. The area of this photograph was located near Clohsey Lake campground in the San Isabel National Forest. The photo was taken on July 31, 2010. Forty campers were trapped for a number of hours and 15 eventually had to be rescued by Chaffee County Search and Rescue.

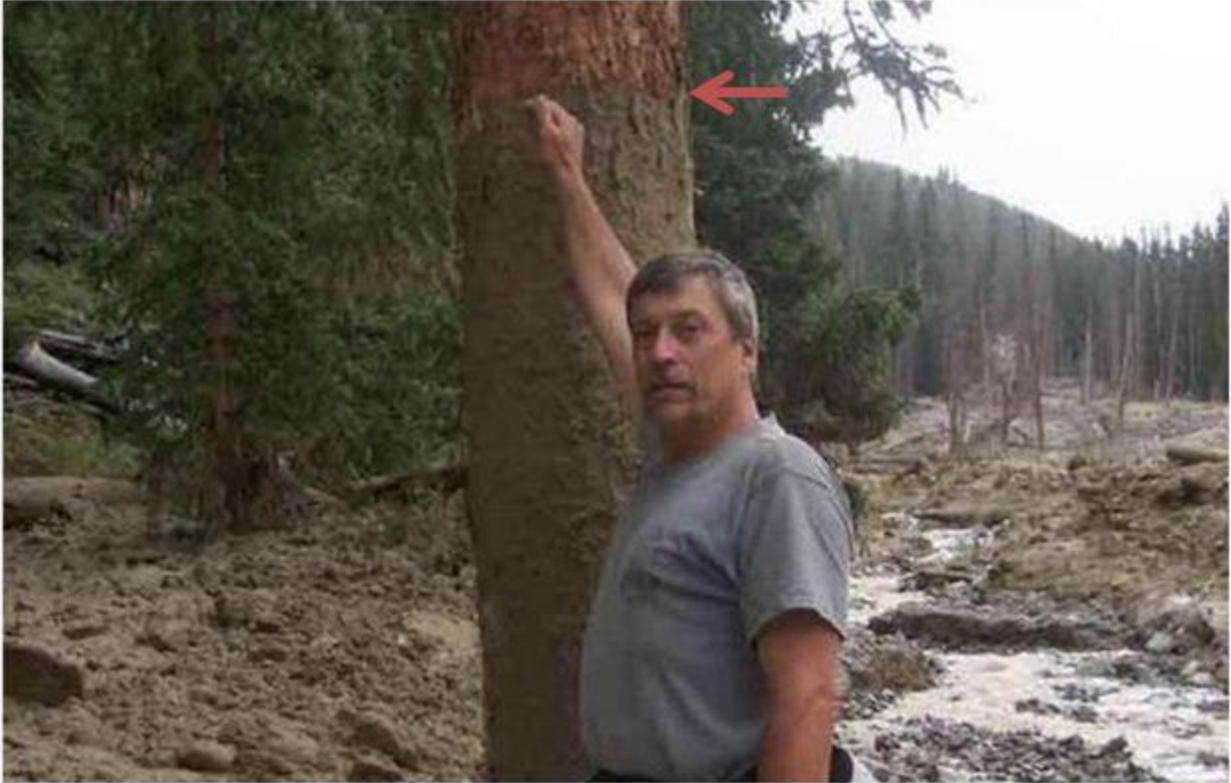
Figure 19. Photograph taken at the Clohsey Lake campground area, San Isabel National Forest on July 31, 2010. This man, who is 5' 10" tall, is indicating the height that one of the two large debris flows reached as it moved through the area (red arrow). Photograph by Mary Widner.

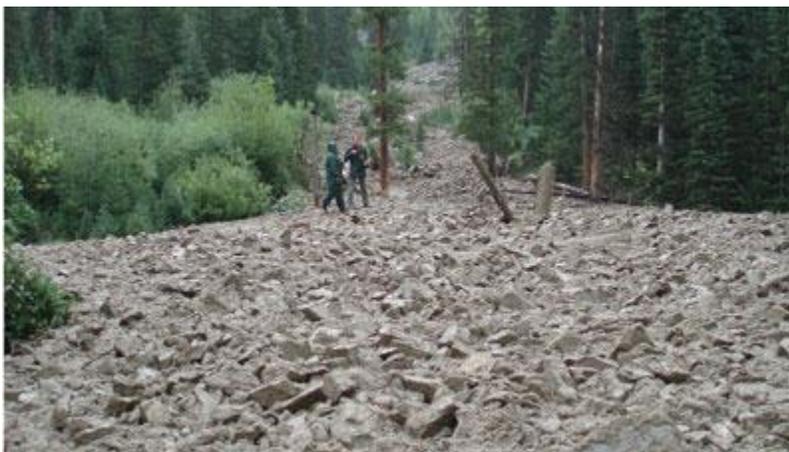
Figure 20. One of two debris flows blocking Clohsey Lake Road in the San Isabel National Forest, near Leadville, Colo. Forty campers were initially trapped and 15 had to be rescued. Photograph by Tim Ransom.

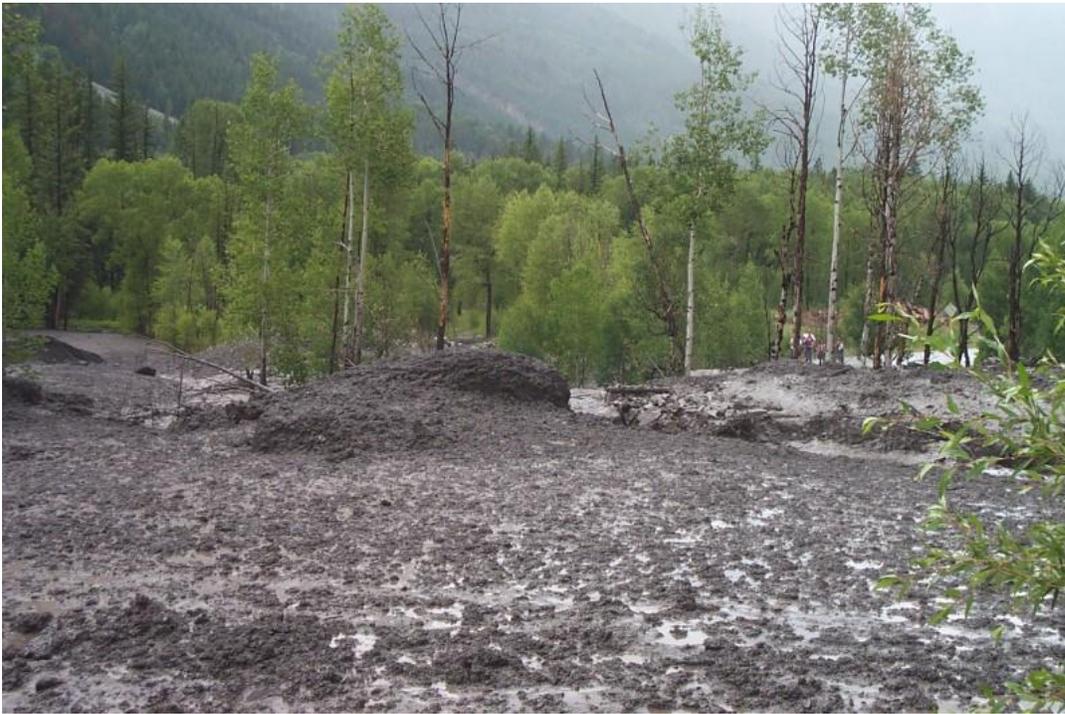
Figure 21. Photograph of a debris flow near Clohsey Lake in the San Isabel National Forest, near Leadville, Colo. Photograph courtesy of Jon Morrissey, US Department of Agriculture National Forest Service.

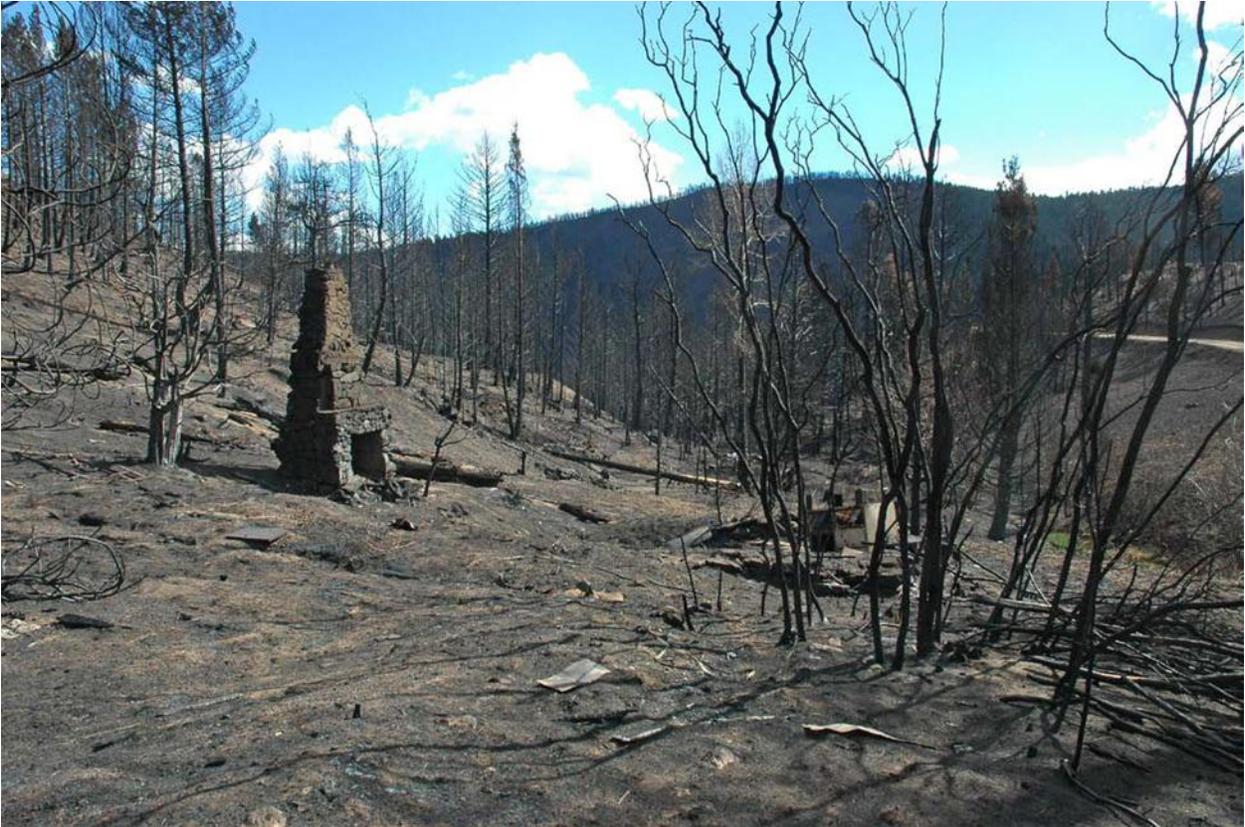
Figure 22. Fourmile Fire burn area, northwest of Boulder, Colo. Photograph by John G. Elliott, US Geological Survey, September 23, 2010.

On September 6, 2010, a fire occurred in Fourmile Canyon, 5 mi northwest of Boulder, Colo. The fire burned 26 km² (6,400 acres) and destroyed 169 homes (fig. 22). The wildfire stripped the area of vegetative ground cover and increased the potential for sudden and destructive flooding and debris flows. More than 60 percent of the burn area drains into Boulder Creek with another 18 percent draining into the Fourmile Canyon Creek. Studies by local, federal, and private-sector scientists suggested an increased risk of flooding along the Boulder and Fourmile Canyon creek floodplains for between 2 and 10 yr, with the increased risk measured at mild to severe (Boulder Daily Camera, 03/01/2011).
