Landslides in Colorado, USA: Impacts and Loss Estimation for the Year 2010

By Lynn M. Highland

Open-File Report 2012–xxxx

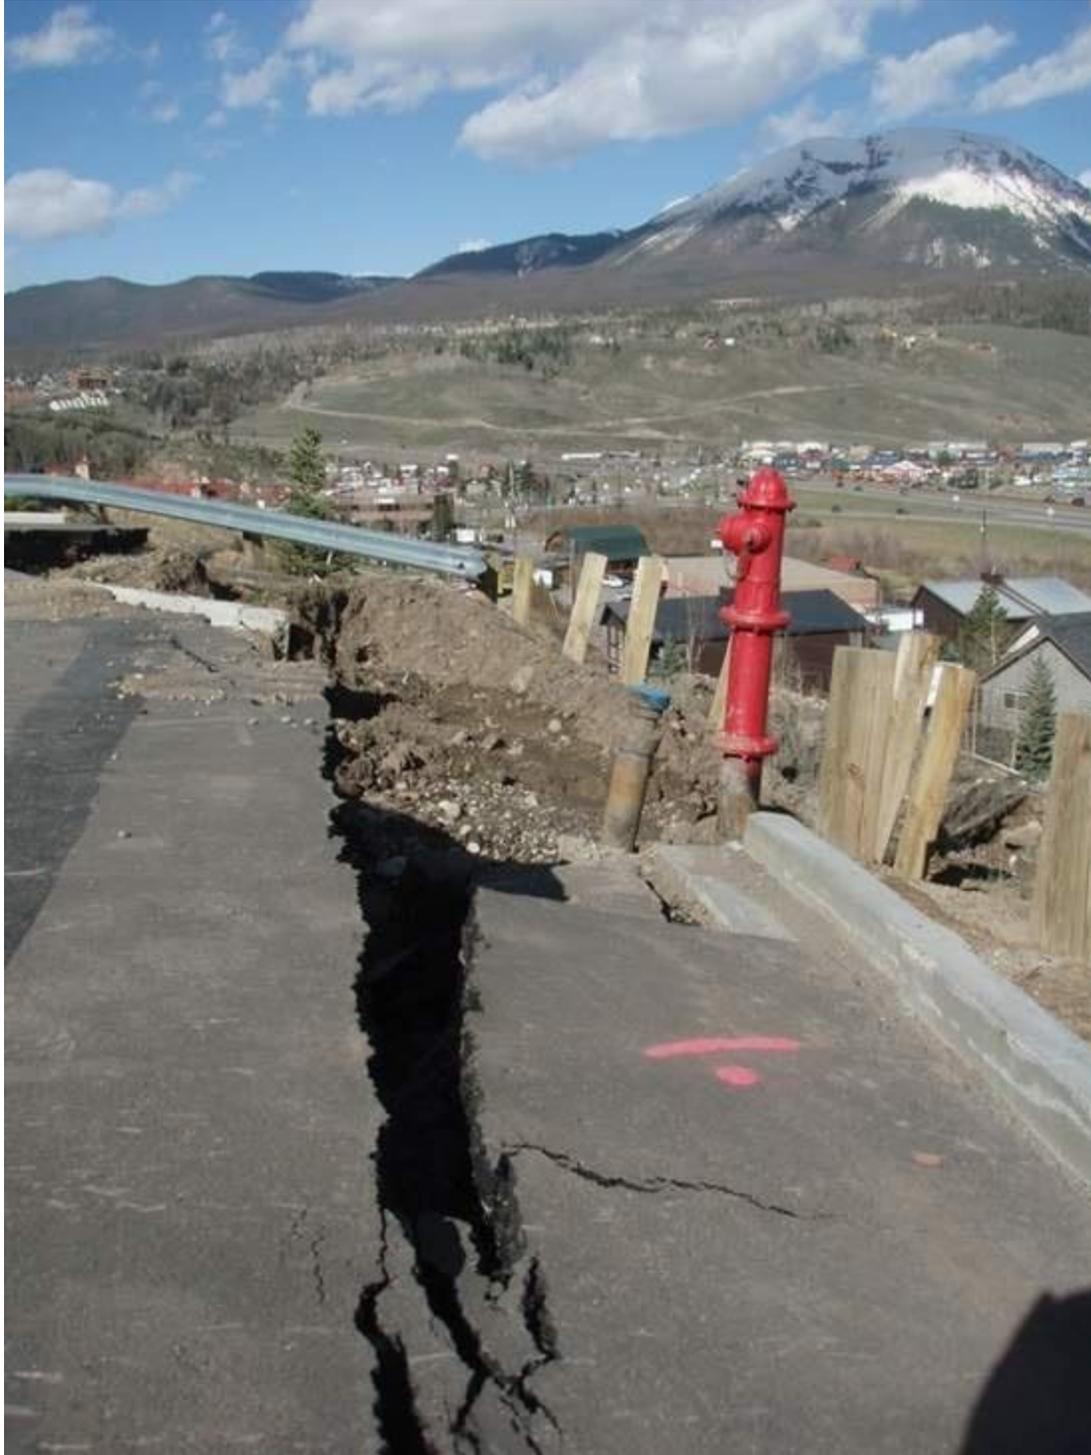
- October 29, 2010—A rock slide occurred behind a Walgreens store in Dillon, Colo. A water-main break sent water down a 20-m (60-ft) retaining wall, causing it to fail. Two homes were evacuated and Little Beaver Trail was closed. Figure 23 shows a photo of road damage that occurred when the retaining wall failed. (Summit Daily News, 01/27/2010).

Figure 23. Slumping roadway above a retaining wall near Dillon Valley Reservoir. Officials are trying to determine what caused the retaining wall to fail after a water main broke nearby. Photograph by Lake Dillon Fire-Rescue.
