SEDIMENT DYNAMICS IN THE RESTORED REACH OF THE KISSIMMEE RIVER  
BASIN, FLORIDA: A VAST SUBTROPICAL RIPARIAN WETLAND<sup>†</sup>E. R. SCHENK<sup>a\*</sup>, C. R. HUPP<sup>a</sup> and A. GELLIS<sup>b</sup><sup>a</sup> U.S. Geological Survey, National Research Program, Reston, Virginia USA<sup>b</sup> U.S. Geological Survey, Maryland Water Science Center, Baltimore, Maryland USA

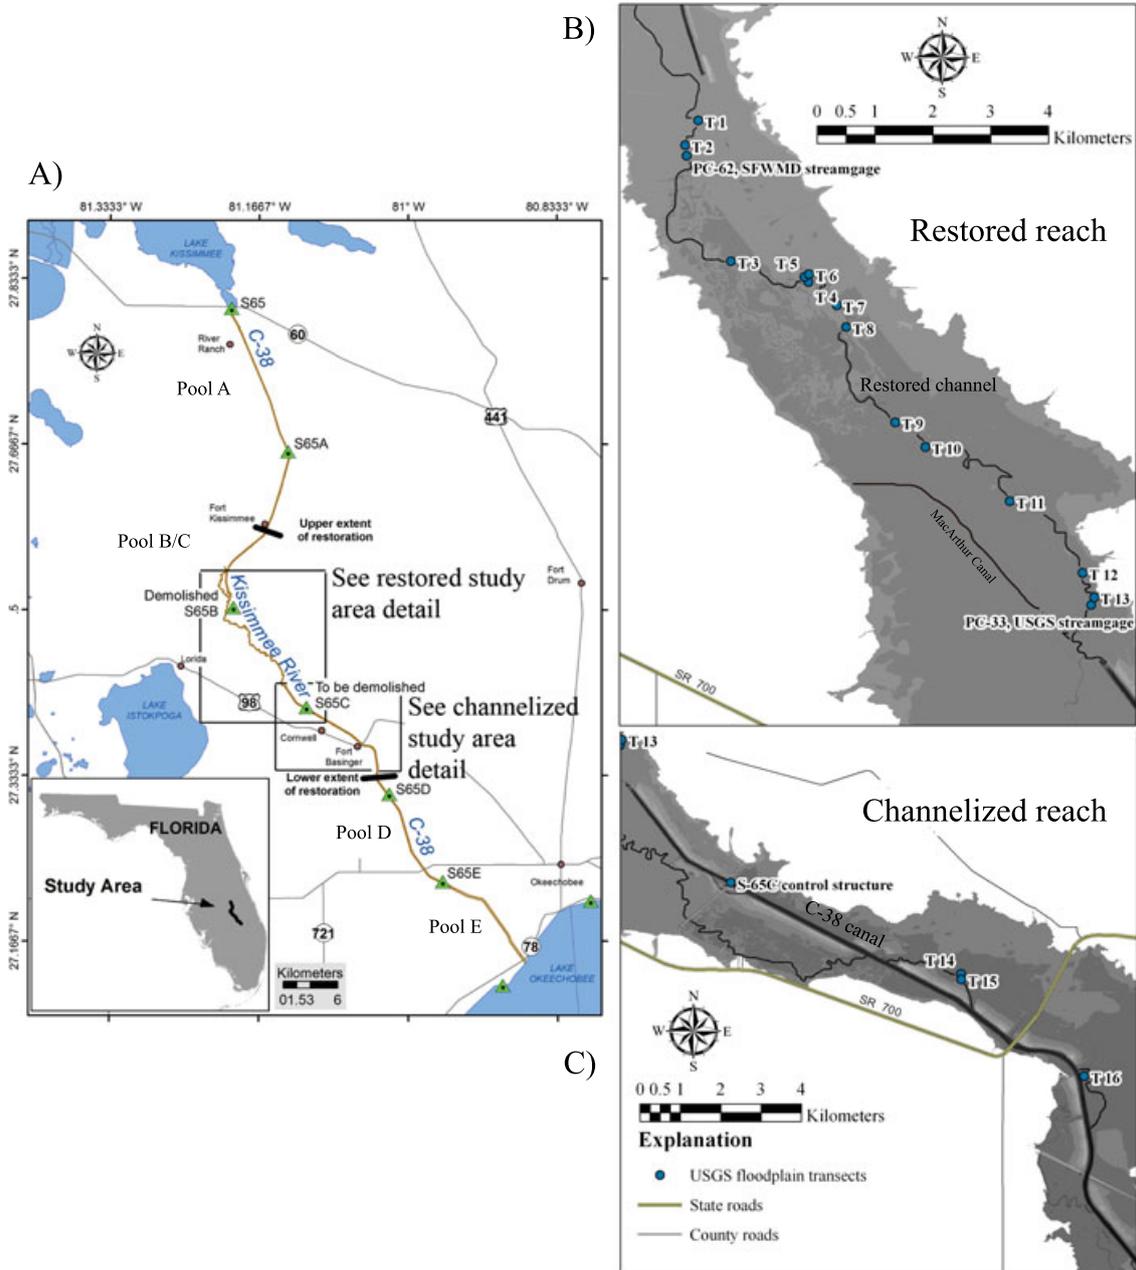
Figure 1. (A) Kissimmee River including lock structures and detailed maps of transect locations in both the restored study area in (B) Pool B/C, location of PC-62 and PC-33 streamgages, and (C) the channelized, unrestored Pool D. Transects on Pool D begin near the remnant river channel, not the channelized active river (labeled as the C-38 canal). Shading on detailed maps (B and C) represents elevation; darker shades are lower in the landscape than lighter shades. Portions adapted from Mossa *et al.* (2010). This figure is available in colour online at [wileyonlinelibrary.com/journal/rra](http://wileyonlinelibrary.com/journal/rra)

(Figure 1C). Transects were numbered from upstream to downstream and contained three to 11 sampling points each. Sampling points consist of white feldspar clay pads and associated sediment samples. Periodic measurements were made of deposition on the clay pad as well as texture, bulk density, and composition of the deposits (carbon and phosphorus were measured in a subset of these points).

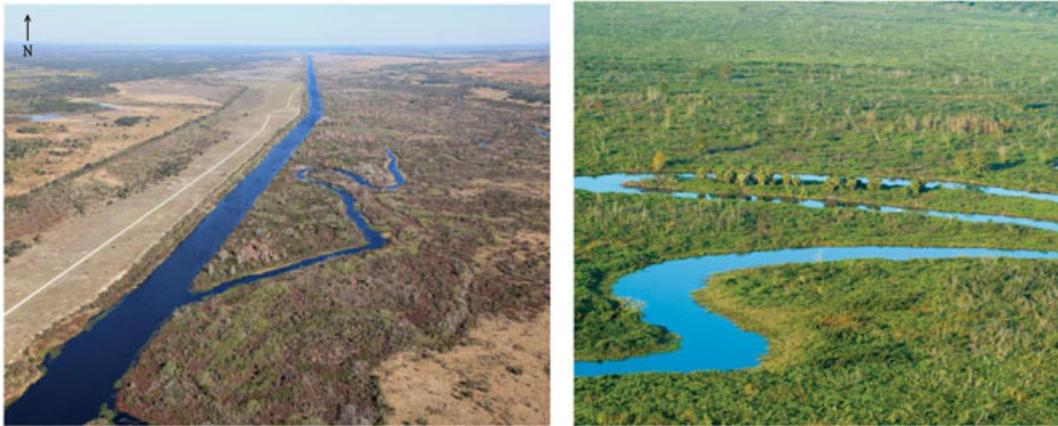
Figure 2. Aerial photos in 2005 of an example of the C-38 canal with a portion of a remnant river channel (left) and a naturalized reach of the Kissimmee River (right). Photo credits: Brent Anderson, SFWMD. This figure is available in colour online at [wileyonlinelibrary.com/journal/rra](http://wileyonlinelibrary.com/journal/rra)

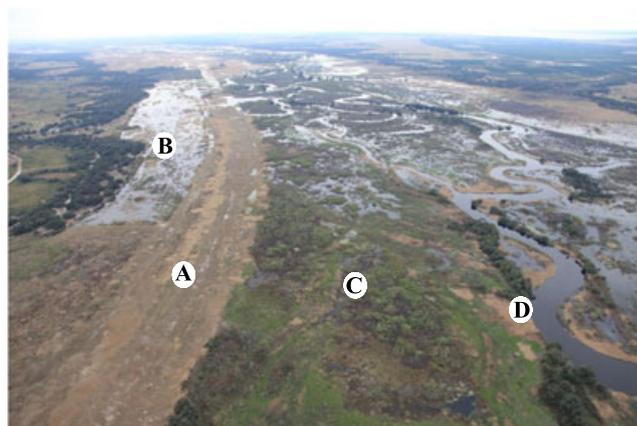
Figure 3. An aerial photograph of the four dominant floodplain landscape types along the Kissimmee River. The backfilled C-38 canal, borrow areas to fill the canal, the natural floodplain, and levees are depicted by the letters A, B, C, and D, respectively. The naturalized channel is on the right-hand side of the photograph. Photo credit: Brent Anderson, SFWMD, February 2010. This figure is available in colour online at [wileyonlinelibrary.com/journal/rra](http://wileyonlinelibrary.com/journal/rra)

The restored Kissimmee River floodplain was separated into four categories: backfilled C-38 canal, borrow areas used to backfill the canal, original floodplain, and levee (Figure 3). Borrow, backfill, and natural floodplain landscape designations were assigned by the South Florida Water Management District (SFWMD) and provided in a GEOGRAPHIC INFORMATION SYSTEMS (GIS) format for our

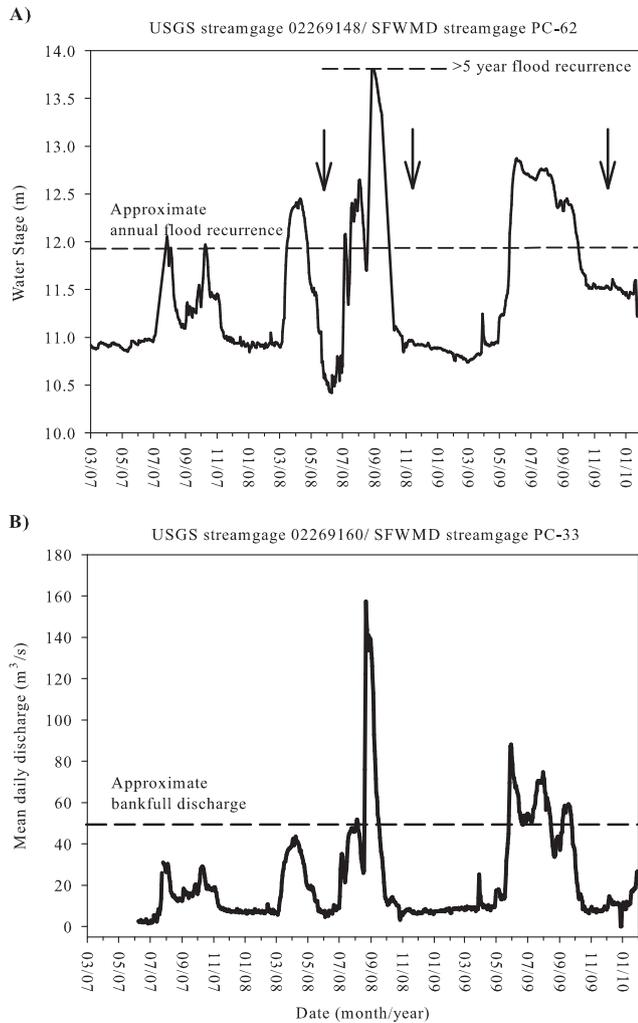
Figure 4. (A) Mean daily flow measured at the PC-62 streamgage near the old Pool B/C control structure. Arrows indicate dates when sediment deposition above clay pads was measured. The approximate annual and greater than 5-year flood recurrence is also noted (from Leroy Pearman, USGS Orlando, Florida, personal communication). (B) Mean daily discharge at the PC-33 streamgage near Basinger, Florida. Approximate bankfull discharge is also noted

and the USGS PC-33 streamgage were both used to determine the flow regime during the study (Figure 4). The SFWMD also operates a streamgage at the upstream S65A control structure; these data were used to determine upstream hydrologic inputs.

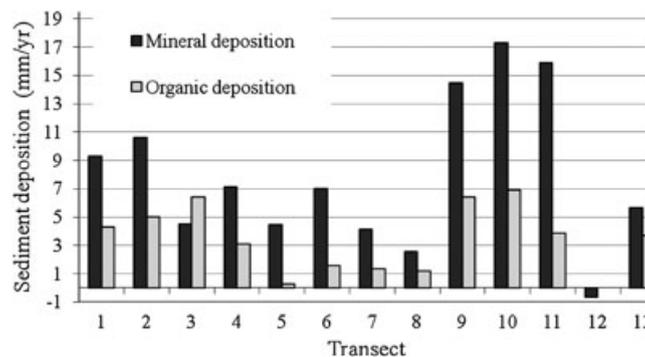
Figure 5. Mean mineral and organic sedimentation by transect from upstream to downstream in Pool B/C

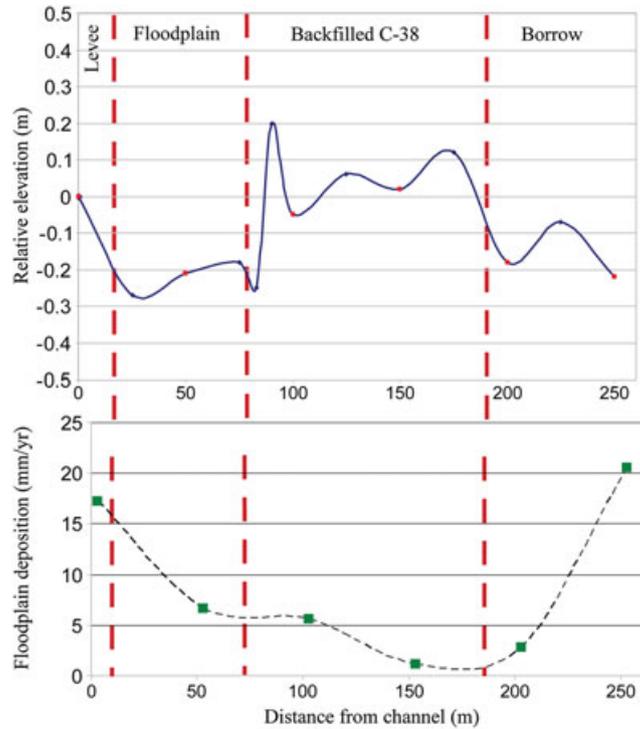
Figure 6. Relative elevation and floodplain deposition along a transect with all four landscape classifications (transect 7). The transect has six field-spar clay pads (marked by squares in the bottom graph). The pad closest to the channel is on the levee, there is one pad on the floodplain, two pads on the backfilled C-38 canal, and two pads on the borrow landscape. This figure is available in colour online at [wileyonlinelibrary.com/journal/tra](http://wileyonlinelibrary.com/journal/tra)

Sediment deposition, organic content, and bulk density varied greatly between landscape types, probably driven by pronounced elevation differences (Figure 6) between the four landscape categories (Table I). Natural floodplain areas represent the majority of our monitored sites and have the highest soil organic matter composition of the four landscape types. The majority of mineral sedimentation, on the restored floodplain, occurs along main channel levees.

Organic deposition was positively correlated with fine sediment deposition. Organic deposition is important for restoring substrate and nutrients that supports historic broadleaf marshes and wet prairie ecosystems (Dahm *et al.*, 1995). Fluvial contribution to the organic sediment pool was significant after the first overbank event in 2008 (Table IV). The nearly fourfold increase in organic content indicates the importance of regular wetland inundation. As expected, organic deposition occurred in areas of fine sediment deposition such as floodplain segments low on the landscape. Levee deposits were nearly pure mineral sediment, primarily fine sand. If current sediment deposition patterns continue, marshes should convert to a mix of wet prairies and broadleaf marshes, whereas levee sites should support less hydric species similar to the historic patterns of cypress and willow (Milleson *et al.*, 1980; Dahm *et al.*, 1995). The backfilled canal will probably take longer to support natural vegetation types because of the low soil organic content. Organic deposition was also lower on backfilled sites than other floodplain landscape types (Table I) probably because of the higher elevation (Figure 6).

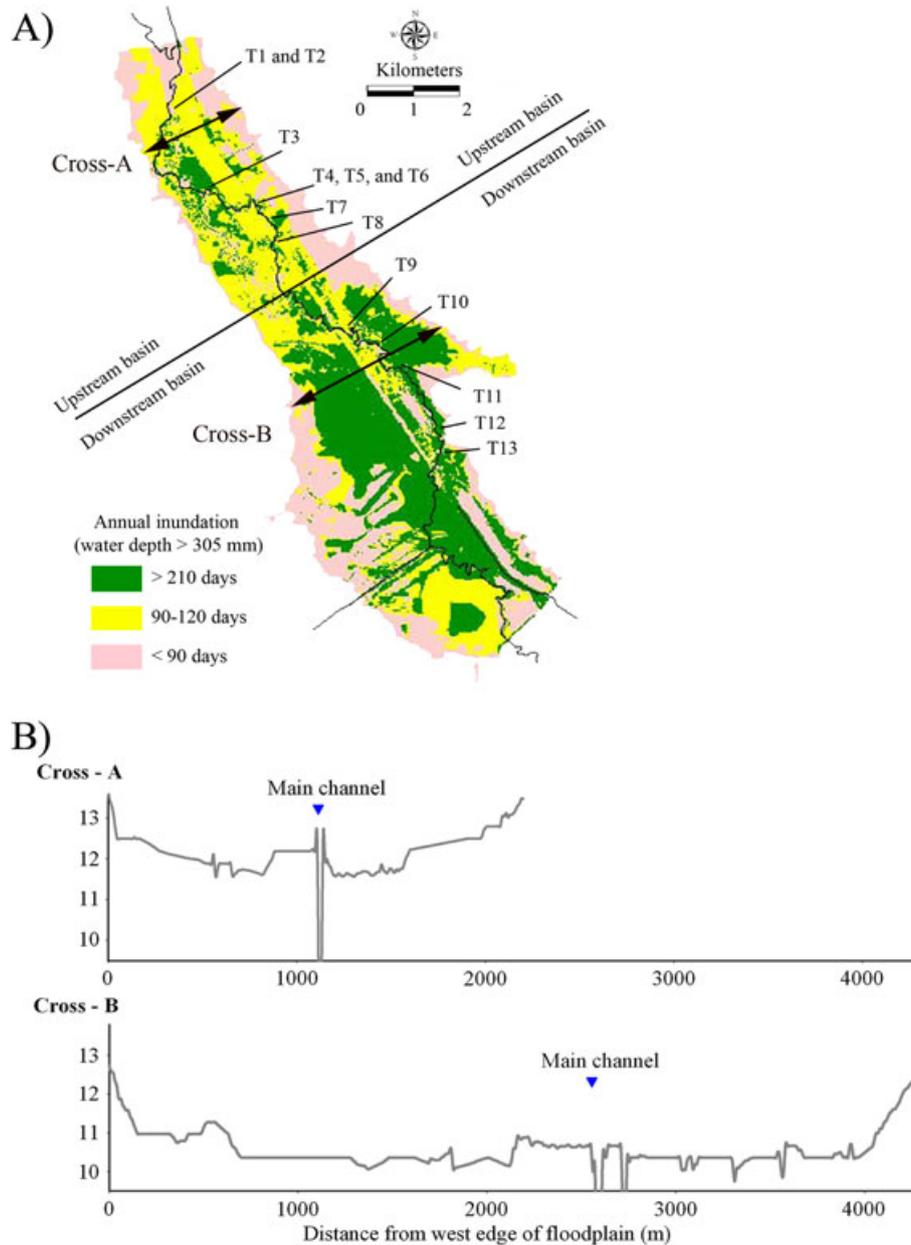
Figure 7. (A) The restored Kissimmee River basin (Pool B/C) separated into an upstream sub-basin dominated by a single-thread river channel and a persistently inundated downstream sub-basin. Annual flood inundation was calculated on 19 April 2010 using the SFWMD Water Depth Assessment Tool (Ruthey *et al.*, 2010). Floodplain monitoring transects are included for reference to sediment deposition rates. (B) Two DEM-derived valley–wall to valley–wall cross-sections demonstrating the change from a single-thread system to a more complex downstream system. This figure is available in colour online at [wileyonlinelibrary.com/journal/trra](http://wileyonlinelibrary.com/journal/trra)

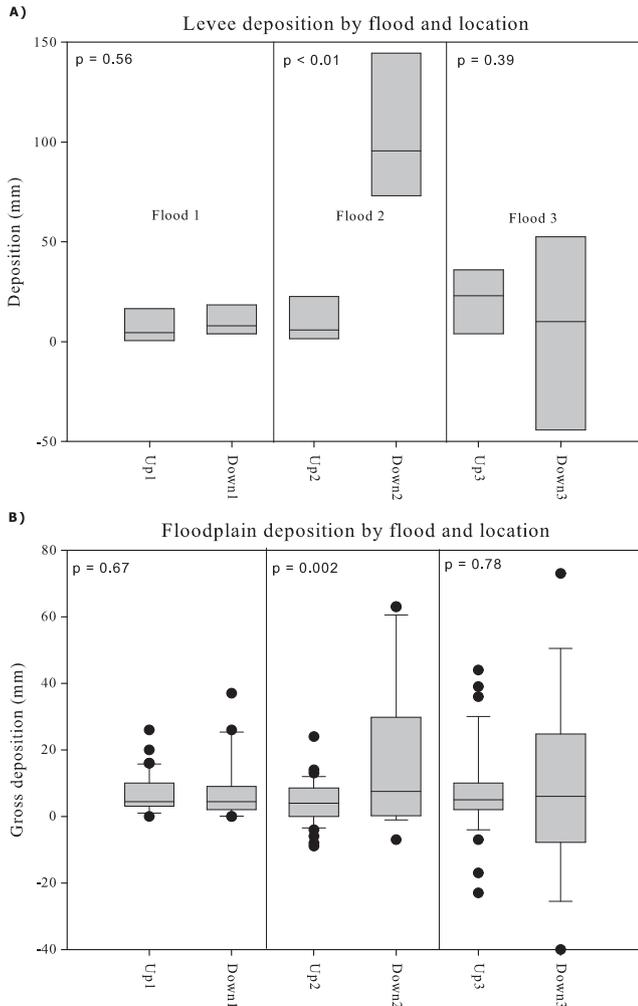
Figure 8. (A) Sediment deposition (mm) by flood event on the upstream single-threaded channel levee (up1, 2, or 3) and the downstream basin channel levee (down1, 2, or 3). (B) Sediment deposition by flood event on the upstream single-threaded channel floodplain (up1, 2, or 3) and the downstream persistently inundated floodplain (down1, 2, or 3). Levee sites were delineated as within 5 m of an active channel during flood stage; floodplain sites are defined as all other clay pad sites in the study regardless of landscape type. Flood 1 occurred in Spring 2008, flood 2 was Tropical Storm Fay in August 2008, and flood 3 was in Summer 2009

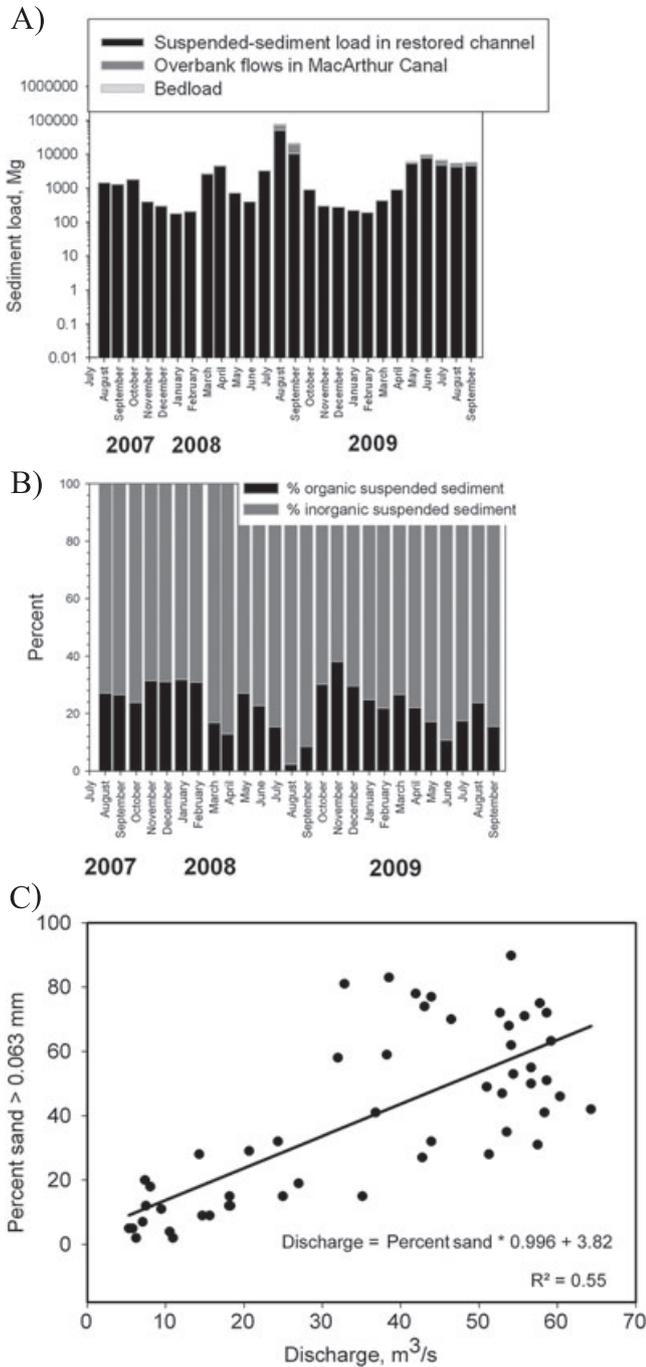
Figure 9. (A) Total monthly suspended sediment loads and bedload measured at PC-33 and estimated suspended sediment loads in MacArthur Canal, (B) percentage of organic and inorganic contents of monthly suspended sediment measured at PC-33, and (C) sand transported in suspension past the PC-33 gage

The total monthly organic content of the suspended sediment measured at the PC-33 streamgage ranged from 2% to 38% (Figure 9B). During the three storm periods, the organic suspended-sediment load ranged from 3% to 16% of the total for each flood event. The lowest organic percentage occurred during Tropical Storm Fay. The inorganic suspended-sediment load percentages for the period of study were highest during the three storm events (Table IV). The transport of sand in suspension is correlated with discharge and for overbank events ( $> 50 \text{ m}^3 \text{ s}^{-1}$ ). The sand in suspension for discrete samples ranged from 28% to 90% (Figure 9C). Using the relation of flow and percentage of sand in Figure 9C, it is estimated that 62 800 Mg or 62% of the total suspended-sediment load for the period of study was transported as sand. During the three storm events, 70% of the suspended-sediment load was sand and accounted for 92% of total annual suspended sand load (Table IV).

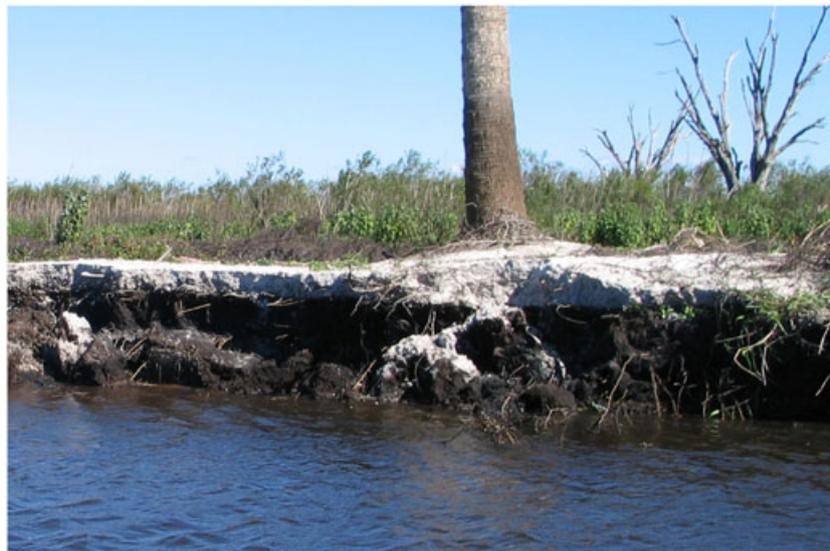
Figure 10. Levee formation following Tropical Storm Fay along a straight river reach. Well-sorted fine sand was deposited approximately 0.3 m deep along many sections of the bank (in white in the picture). Note the mass wasting that has occurred since the flood (flood occurred August/September 2008, photo was taken in December 2008). This figure is available in colour online at [wileyonlinelibrary.com/journal/rra](http://wileyonlinelibrary.com/journal/rra)

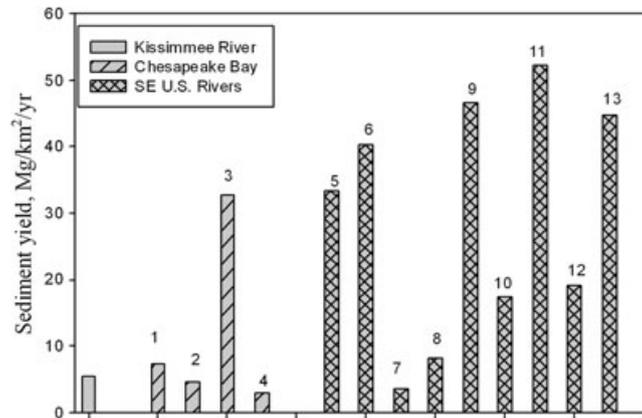
Figure 11. Sediment yield of the Kissimmee River (2007–2009) compared with rivers in the Chesapeake Bay and southeastern US rivers (Holeman, 1968; Curtis *et al.*, 1973; Gellis *et al.*, 2005, 2009) (1. Choptank R., 2. Hunting Creek, 3. Killpeck Creek, 4. Mattaponi R., 5. Alabama R., 6. Alabama R., 7. Apalachicola R., 8. Ogeechee R., 9. Pearl R., 10. Pee Dee R., 11. Sabine R., 12. Tar R., 13. Tombigbee R.)
