SEDIMENTOLOGY OF NEW FLUVIAL DEPOSITS ON THE ELWHA RIVER,
WASHINGTON, USA, FORMED DURING LARGE-SCALE DAM REMOVALA. E. DRAUT^{a*} AND A. C. RITCHIE^b^a U.S. Geological Survey, 400 Natural Bridges Drive, Santa Cruz, CA 95060, USA^b Olympic National Park, National Park Service, Port Angeles, WA 98362, USA

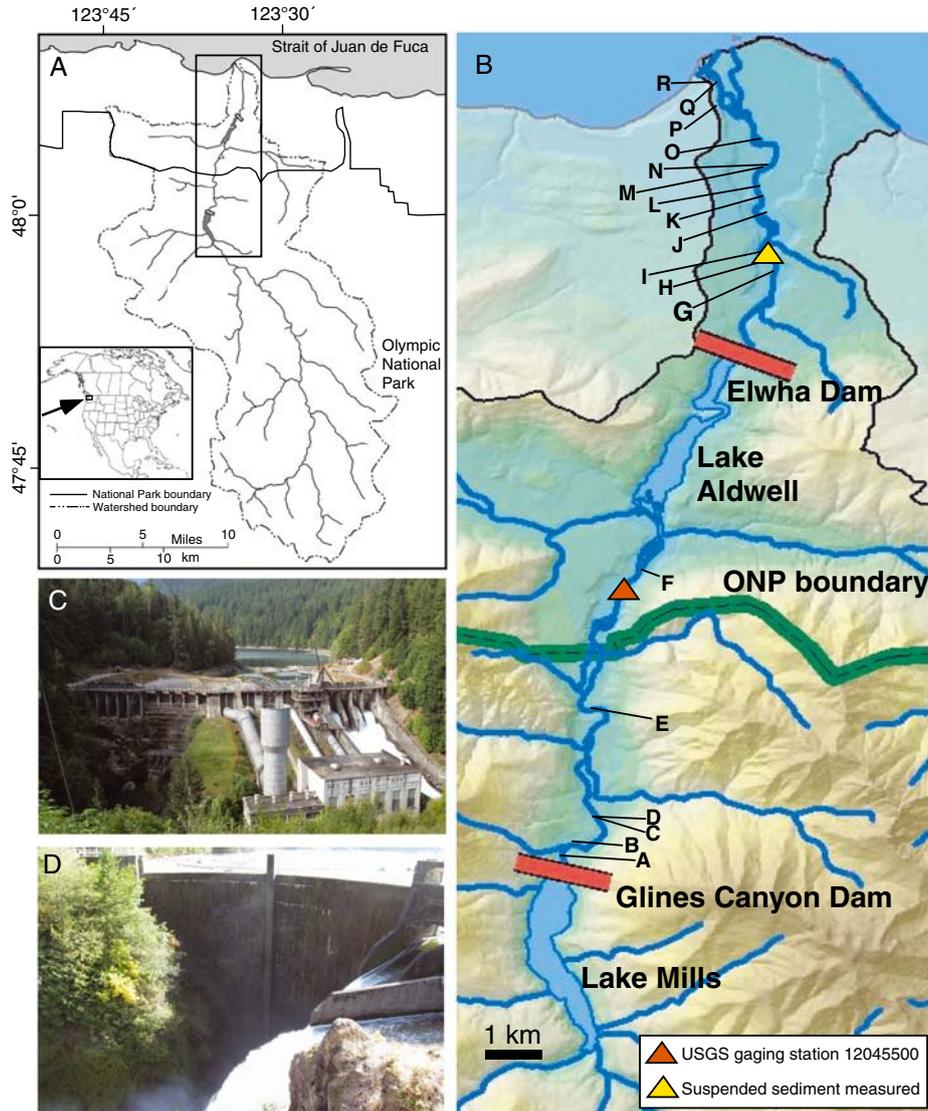
Figure 1. (A) The Elwha watershed, Olympic Peninsula, northwestern Washington, USA. Dashed line shows watershed boundary, solid line Olympic National Park (ONP) boundary. Box outlines the area shown in (B). (B) The ~26-km Elwha River reach affected by dam removal. Sites of Elwha and Glines Canyon Dams are shown as red bars. Former sites of Lakes Aldwell and Mills, which were reservoirs behind the dams, contain sediment deposits eroded by the river during and after dam removal. Labels A–R show locations of sedimentary profiles examined for this study (Appendix lists distances of each profile from the dams). Orange triangle is U.S. Geological Survey gauging station 12045500, where water discharge is measured; yellow triangle shows location of suspended-sediment monitoring station. The river between the two dams is known informally as the ‘middle reach’; the reach downstream of Elwha Dam is known as the ‘lower reach’. (C) Elwha Dam and (D) Glines Canyon Dam in September 2011 shortly before deconstruction began; photographs courtesy of the National Park Service.

The 833-km² Elwha watershed drains steep, mountainous terrain of the Olympic Peninsula (Figure 1A), which contains metasedimentary and igneous rocks within the forearc region of the Cascadia subduction zone (e.g. Brandon *et al.*, 1998). Steep slopes in this tectonically active basin produce landslides that episodically generate large sediment quantities upstream of the dam sites (Acker *et al.*, 2008). Additional Elwha River sediment sources include sedimentary rocks, glacial outwash alluvium and proglacial lacustrine deposits exposed in bluffs, canyons and valley walls along the lower Elwha River (Tabor and Cady, 1978; Polenz *et al.*, 2004). The river flows through alternating bedrock canyon and alluvial floodplain reaches. Within its alluvial reaches, the Elwha channel is best classified as an anabranching or island-braided channel (cf. Harwood and Brown, 1993; Knighton and Nanson, 1993). Although in some reaches there is one wandering channel (as in order B2 of Nanson and Croke, 1992; see also Church, 2002), in other reaches, bars and vegetated islands separate multiple channel threads. Before dam removal, bed sediment in the Elwha River downstream of the dams was dominantly granule-sized to cobble-sized. This armoured bed, significantly coarser than the natural bed sediment above the dams, resulted from the dams having blocked downstream sediment transport (Pohl, 2004; Draut *et al.*, 2011). The Elwha floodplain is heavily vegetated with hardwood and conifer trees, and smaller shrubs and saplings.

Elwha and Glines Canyon Dams, 32 m and 64 m high, respectively, were concrete dams situated 13.7 km apart on the Elwha River (Figure 1). The dams were completed in 1913 (Elwha Dam) and 1927 (Glines Canyon Dam) to provide hydropower and water to a paper and timber-mill operation and to the city of Port Angeles. Dam operations largely mimicked natural hydrology, but with more rapid daily flow fluctuations and lower daily minimum flows (Johnson, 1994; Pohl, 1999). Annual peak discharges on the Elwha River occur during storms between October and March; secondary peaks with longer duration occur in late spring snowmelt. The dams virtually eliminated upstream sediment supply to the middle and lower Elwha River (between and below the dam sites, respectively), except for suspended-sediment passage during large floods; before dam removal, fluvial sediment transport to the coastal ocean

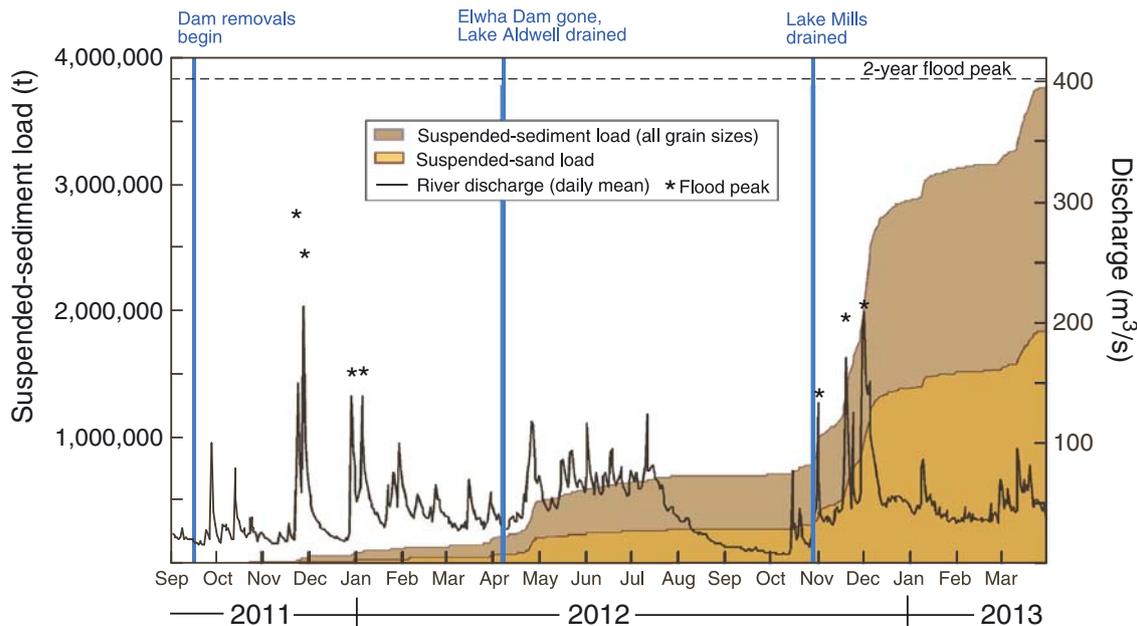
Figure 2. Hydrograph, suspended-sediment load (all grain sizes) and suspended-sand load measured during the first 18 months into dam removal on the Elwha River. Discharge is measured at USGS gauging station 12045500 (Figure 1B). Solid black line shows daily mean discharge; asterisks indicate instantaneous flood-peak discharge. Dashed line shows 2-year flood flow ($401.6 \text{ m}^3/\text{s}$) calculated from a log Pearson type III frequency analysis using discharge data from 1898 through 2012. Suspended-sediment-load data are those of Curran *et al.* (2013), measured at the location shown by the yellow triangle on Figure 1B. Dam removal progressed in graduated stages between September 2011 and November 2012. Glines Canyon Dam deconstruction did not proceed any further between November 2012 and profile sampling in March 2013, but resumed in October 2013. This figure is available in colour online at wileyonlinelibrary.com/journal/rra

Dam remained to be removed. Volumetric change estimates using ‘Structure-from-Motion’ photogrammetric topography analysis (cf. Westoby *et al.*, 2012) from a novel aerial imaging system indicate that a total of $6.1 \times 10^6 \text{ m}^3$ of sediment had moved downstream from both of the reservoir-sediment deposits as of spring 2013 (A. C. Ritchie, unpublished data). The first two years of dam removal included above-average winter snowpack and spring snowmelt flows, but below-normal storm flood discharge in winter. Although flows resulting from several winter storms moved sediment downstream, flood peaks during winter 2011–2012 and winter 2012–2013 were substantially below that of the 2-year flood (Figure 2).

and suspended load accordingly increased (Figure 2). The greyish brown sandy unit, which underlay the grey mud along the lower Elwha River banks in April 2012 (Figure 4A) and whose colour did not match that of typical Elwha watershed sediment, was probably reworked material from some of the ~80 000 m³ of fill used to build temporary earthen coffer dams at the Elwha Dam site

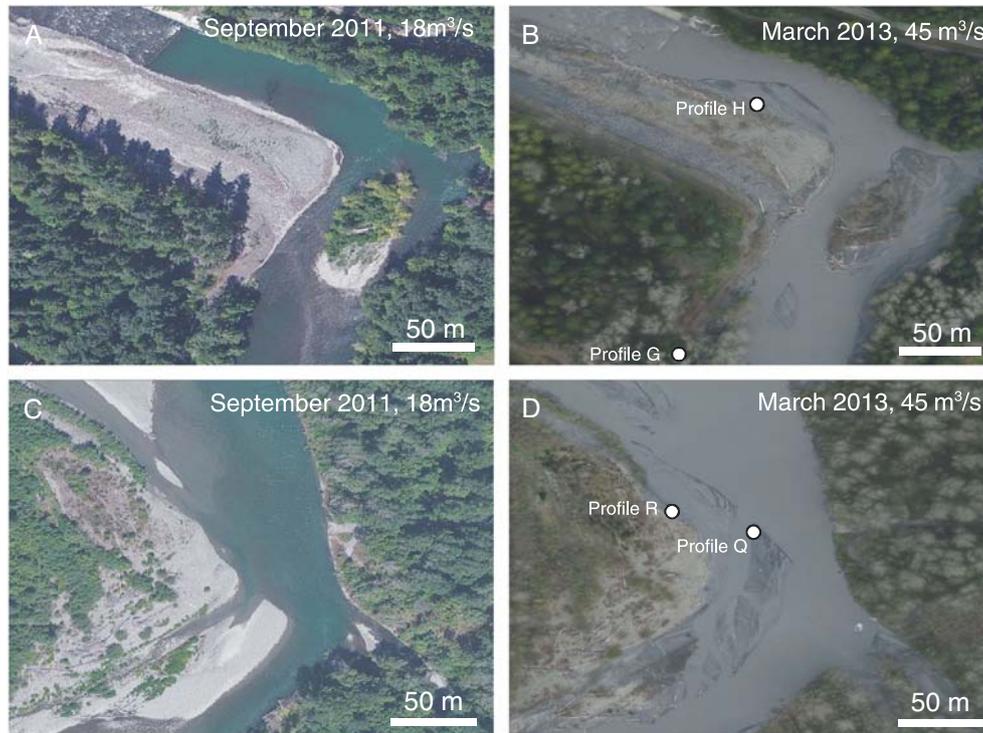
Figure 3. Orthorectified aerial images showing contrast between pre- and post-dam-removal channel configuration and fluvial sediment. (A) and (B) show a location 2 km downstream of the Elwha Dam site (15.7 km downstream of the Glines Canyon Dam site) in September 2011 and March 2013, respectively; engineered riffle at the top of these images is part of the Elwha Surface Water Intake facility diverting water toward a fish hatchery and municipal water-treatment plant. (C) and (D) show a location 7.2 km downstream of the Elwha Dam site (20.9 km downstream of the Glines Canyon Dam site) in September 2011 and March 2013, respectively. Locations of sedimentary profiles sampled for this study are shown in (B) and (D). Differences between (A) and (B) and between (C) and (D) include the appearance of new sediment that is finer than the pre-dam-removal cobble bed, and formation of new mid-channel bars. The post-dam-removal fine sediment also has a dark grey colour distinct from that of the older cobble bed. Discharge in the September 2011 images (A) and (C) is $18 \text{ m}^3/\text{s}$; discharge in the March 2011 images is $45 \text{ m}^3/\text{s}$. 2011 images courtesy of the U.S. Department of Agriculture, National Aerial Imaging Program. 2013 images by A.C. Ritchie. This figure is available in colour online at wileyonlinelibrary.com/journal/rra

sediment was substantially finer, in general, than the underlying pre-dam-removal bed sediment (Figures 3, 4, 5A) and dominantly grey to dark grey (5Y 5/1 to 5Y 4/1 on the Munsell colour classification scale), consistent with the colour of sediment in the upper Elwha watershed and with most locations in the Mills and Aldwell reservoir deltas. The 18 sampled profiles exhibited no common vertical sequence of sediment grain size, bedding style or organic content, and had variable post-dam-removal sediment thickness—ranging from 16 to 160 cm, with mean thickness 59 cm and standard deviation 33 cm. Thickness variations could be attributable to sampling-site selection, and larger-scale patterns of bed aggradation will be evaluated as quantitative topographic data become available.

into floodplain areas even during non-flood flows, filling of side channels, and deposition of a range of sediment grain sizes and organic material (Figures 3, 5 and 6). Late fall and winter 2012–2013 deposition occurred not only in quiescent zones of the channel such as in eddies and on the downstream sides of obstacles but also throughout the channel (including the thalweg) and over any inundated floodplain regions.

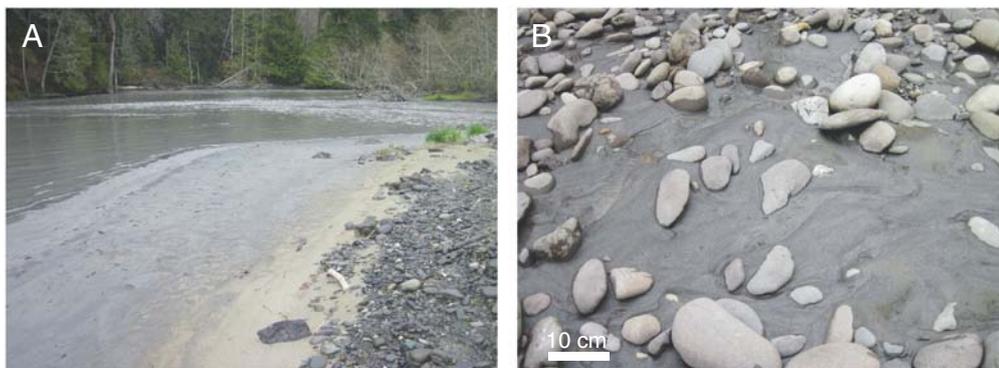
Figure 4. Post-dam-removal sedimentary deposits on the Elwha River as of April 2012. (A) At a location 2.15 km downstream of the Elwha Dam site (15.9 km below Glines Canyon Dam) new deposits <20 cm thick comprised grey mud, inferred to be sourced from Lake Aldwell reservoir material, overlying greyish brown sand reworked from coffer-dam destruction at Elwha Dam. Pre-dam-removal pebble-cobble bed is visible at right side of image. (B) Downstream of Elwha Dam, the pre-dam-removal cobble bed commonly contained new mud filling interstitial spaces, but bed elevation had not yet increased substantially (photo location 4.70 km below Elwha Dam site, 18.4 km below Glines Canyon Dam). This figure is available in colour online at wileyonlinelibrary.com/journal/rra

greyish brown (2.5Y 5/2) sandy material (Figure 4A). The grey to dark grey mud was likely deposited from suspended sediment exported from Lake Aldwell reservoir deposits as Elwha Dam deconstruction gradually lowered the lake level

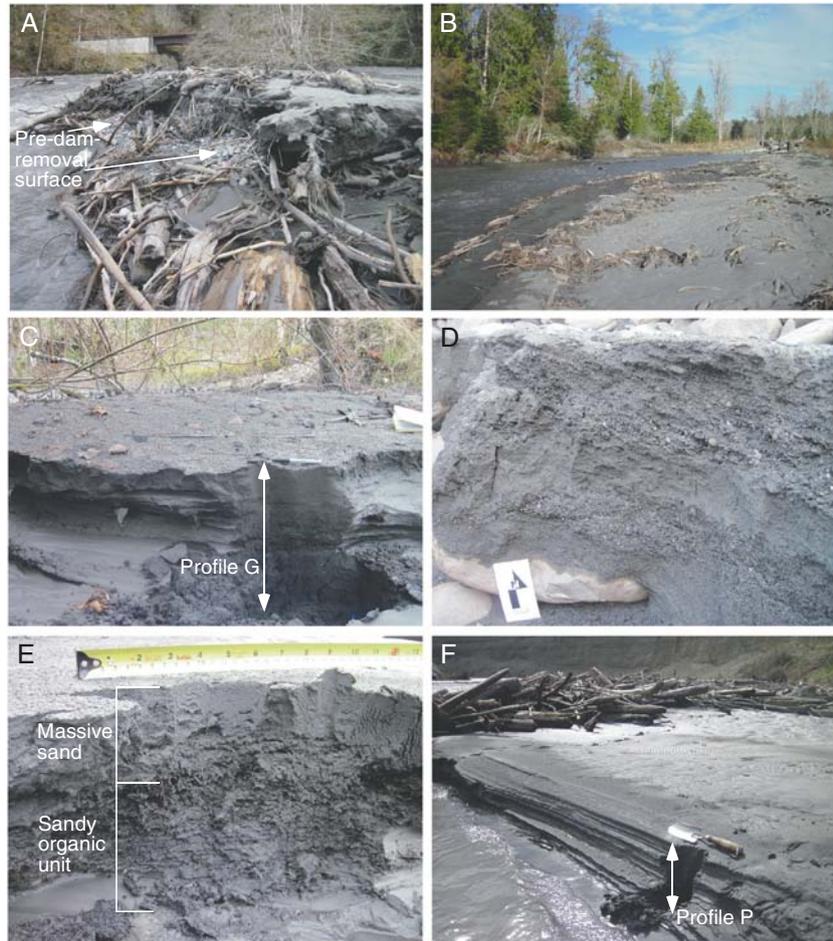
Figure 5. Post-dam-removal sedimentary deposits on the Elwha River as of late March 2013. (A) Coarse sand and woody debris dominate the post-dam-removal deposit 1.7 km below the Glines Canyon Dam site at the upstream end of Altair Campground, Olympic National Park, at Profile C location. The pre-dam-removal cobble bed surface is visible beneath the new, finer sediment and wood. (B) View facing upstream at the site of Profile O, 5.42 km downstream of Elwha Dam site (19.2 km below Glines Canyon Dam site), showing sand and woody debris deposited during dam removal. (C) Floodplain setting 1.94 km below Elwha Dam site (15.6 km below Glines Canyon Dam site), showing Profile G. Base of arrow is at pre-dam-removal forest-floor surface. (D) Flood deposit from a December 2012 high-flow event, dominated by coarse sand and granule layers, at Profile A, 0.25 km downstream of Glines Canyon Dam site. Scale card at base is 15 cm long. (E) Uppermost two sedimentary units within Profile H (2.19 km below Elwha Dam site, 15.9 km below Glines Canyon Dam site), including an organic-rich sandy horizon (TOC content 7.02%; Sample H3, Table I). (F) Sand and woody debris at Profile P location, 6.86 km below Elwha Dam site (20.1 km below Glines Canyon Dam site). This figure is available in colour online at wileyonlinelibrary.com/journal/rra

Organic particles of widely variable sizes were abundant in post-dam-removal Elwha River deposits (from tree trunks to sub-centimetre particles; Figure 5). Of the 12 sedimentary units tested for organic carbon content, which were targeted because organic matter was visible within them in the field (Figure 6), all 12 had TOC content <10% (Table I). These measured values from strata with organic particles small enough to be

sampled (e.g. Figure 5E) must underrepresent the actual organic carbon content in the new deposits, because it is not feasible to include larger woody debris in samples analysed by standard methods (Figure 5A, B, F). Nevertheless, it is notable that two-thirds of the profiles (12 of 18) included visible organic matter in the new deposits, either as distinct wood fragments or as diffuse lenses of smaller particles (Figure 6).

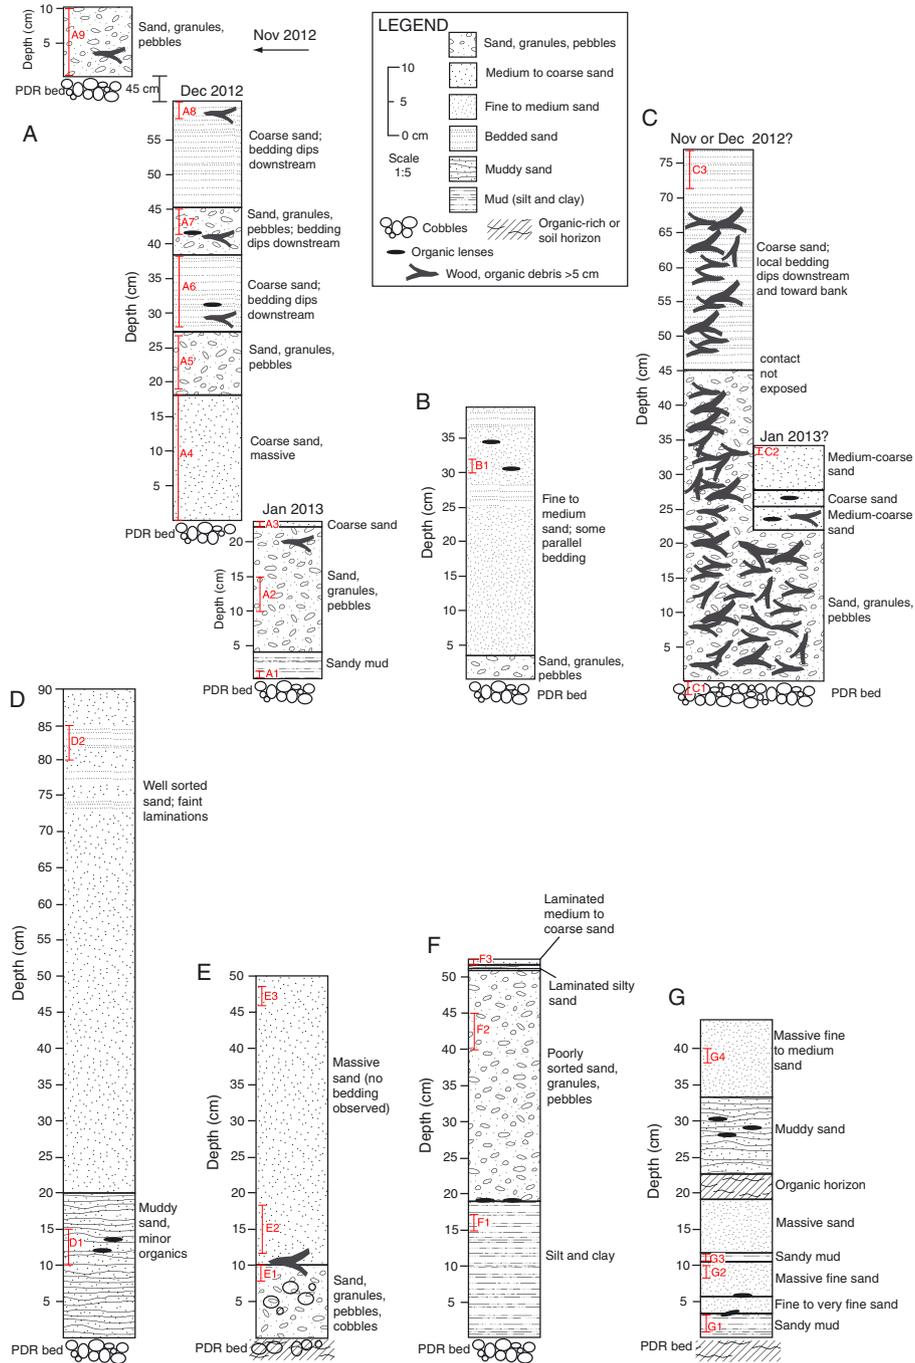
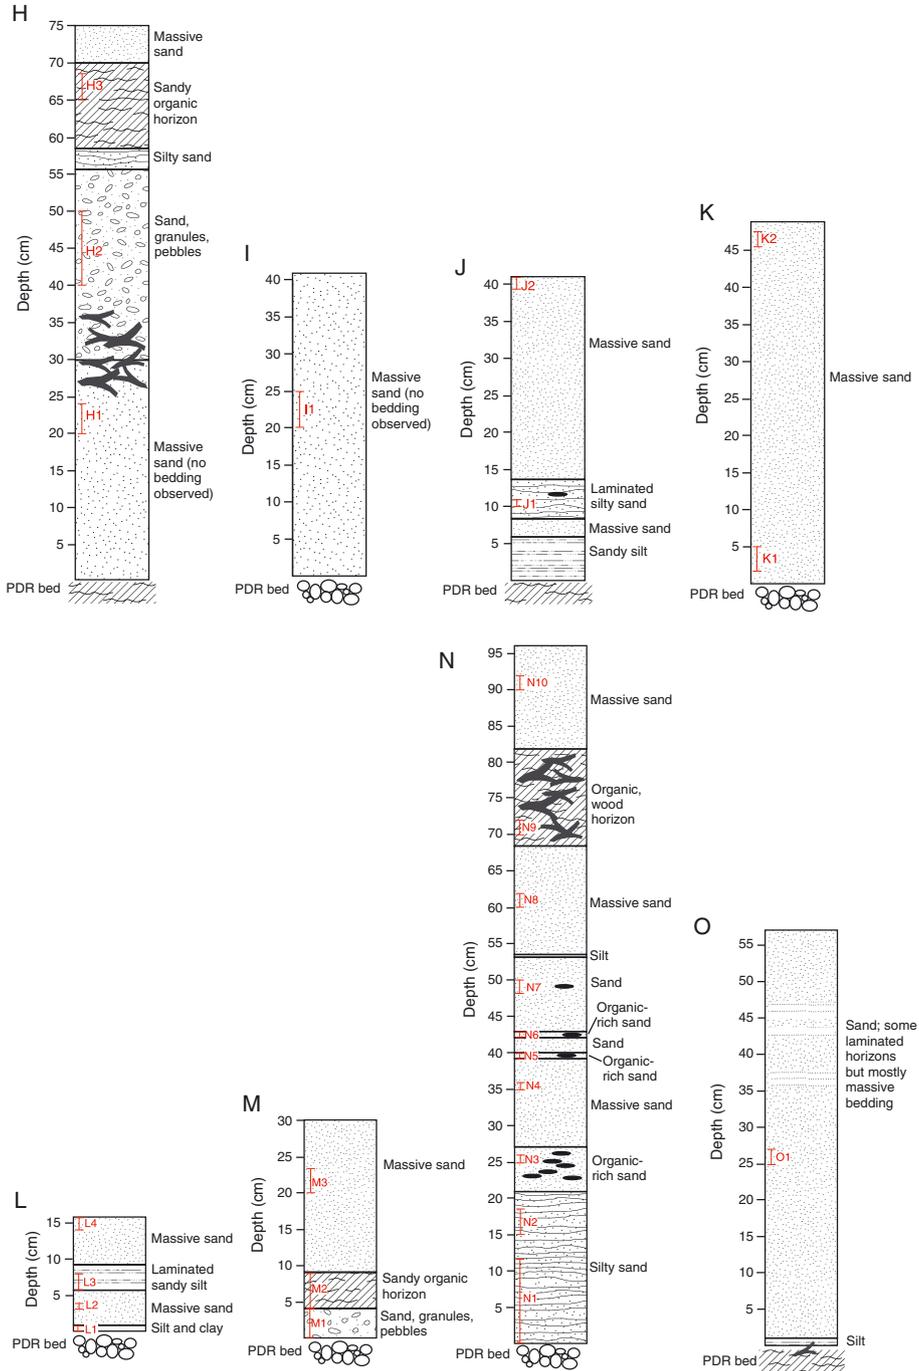
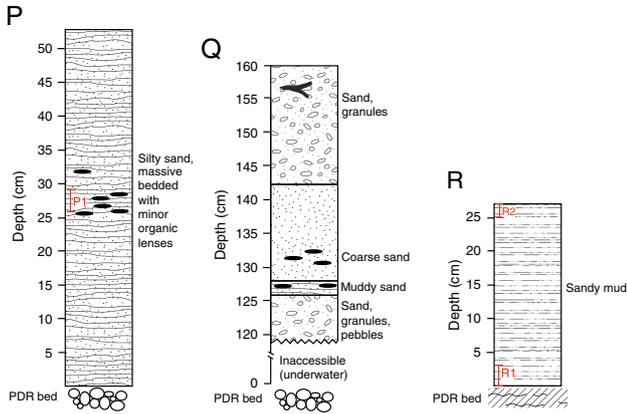
Figure 6. Sedimentary profiles through new fluvial deposits on the Elwha River described in late March 2013. Diagrams are to scale on the vertical axis. Locations of profiles A–R are shown on Figure 1B; numerical distances of each profile with respect to the dams are listed in the Appendix. Samples analysed for grain size and carbon content are indicated in red (see Table I). (A) and (C) represent deposits of more than one flood event, which formed separate deposits at those locations in November 2012, December 2012, and January 2013. This figure is available in colour online at wileyonlinelibrary.com/journal/rra

Despite the rarity of basal mud deposits, silt and clay nevertheless composed a substantial part of most sedimentary profiles studied in March 2013 (Figure 6; Table I). The thicknesses and mud content of mud-bearing sedimentary units were used to calculate an equivalent mud thickness for each profile, that is, an estimate of the proportion of total sediment thickness that was silt and clay (Figure 8; see Appendix for detailed calculations). For sedimentary units judged in the field to contain both sand and mud (those described as muddy sand, silty sand or sandy mud) but for which no grain-size analyses were performed, mud content was estimated conservatively to be 10% (cf. Boggs, 1995). Therefore, equivalent mud thickness estimates (Figure 8) should be considered minimum values. The 18 profiles were thereby estimated to have a mean mud content of 21%, with a median value of 17%. No significant trend existed in mud content with distance downstream (in Figure 8), nor was there a significant difference between mud content in the middle-reach profiles (between the dam sites) and lower-reach profiles (below Elwha Dam) even though the channel slope in the middle reach is greater than in the lower reach (0.006 vs 0.004). This may have been a function of limited sites sampled, especially in the middle reach.

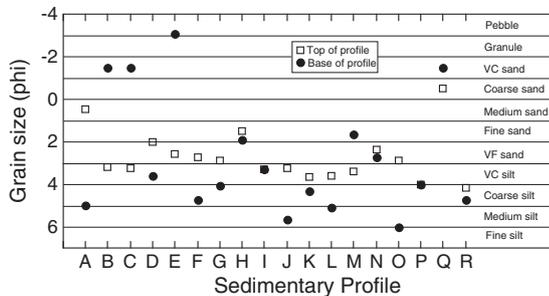
Figure 7. Basal and surficial sediment grain size in post-dam-removal sediment of profiles A–R (lowermost and uppermost sedimentary units above the pre-dam-removal bed), presented in order of increasing distance downstream (distance not to scale). Grain size in the 18 profiles was spatially heterogeneous, with no downstream trend in either basal or surficial grain size

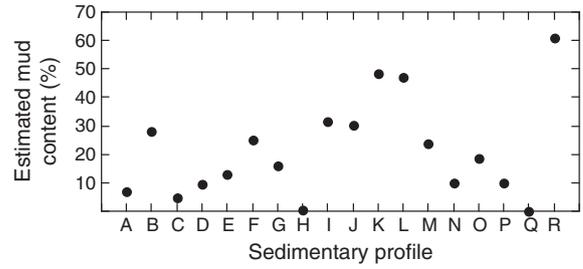
Figure 8. Estimated mud content of 18 sedimentary profiles A–R, presented in order of increasing distance downstream. Mud content (sum of silt and clay) is shown as the proportion of post-dam-removal deposit thickness composed of mud. This was calculated by multiplying the mud content in sedimentary units for which grain size was analysed (Table I) by the thickness of each stratum (Figure 5). For sedimentary units judged to contain both sand and mud in the field but for which no grain-size analyses were performed, mud content was estimated conservatively to be 10% (after Boggs, 1995). Therefore, equivalent mud thickness estimates should be considered minimum values. Details of calculations are given in the Appendix
