# INFORMAL AND FORMAL TRAIL MONITORING PROTOCOLS AND BASELINE CONDITIONS: ACADIA NATIONAL PARK

**INFORMAL AND FORMAL TRAIL MONITORING PROTOCOLS  
AND BASELINE CONDITIONS: ACADIA NATIONAL PARK**

May 2011

Final Report for the USDI, National Park Service  
Acadia National Park

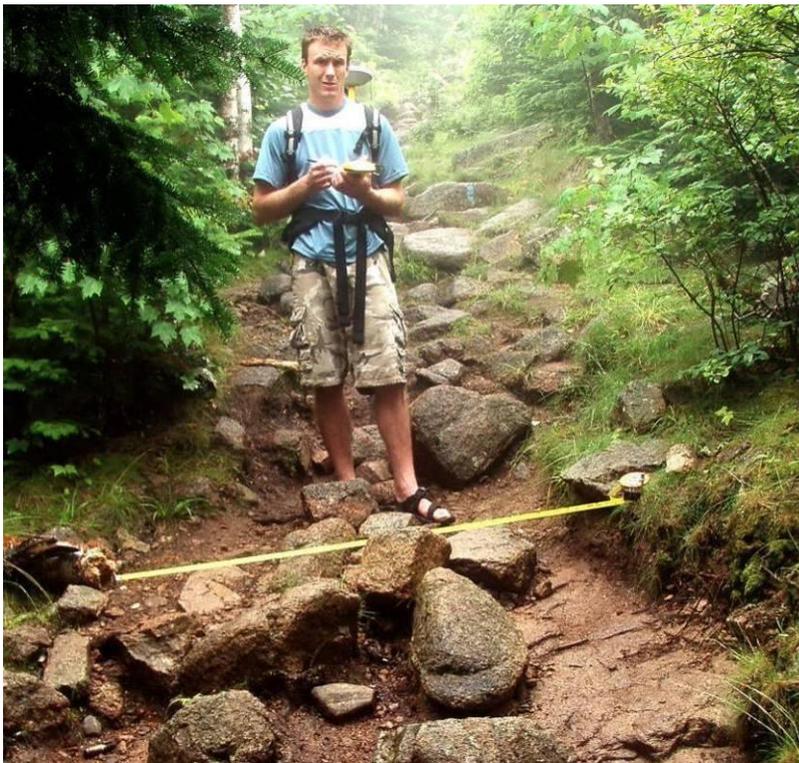
Figure 8. Notice the greater soil loss associated with this fall-line trail alignment compared to the more minimal soil loss for the side-hill aligned trail in Figure 6.

Once a fall-aligned trail becomes incised, water trapped on the tread is exceptionally difficult to direct off and can build in volume, substantially increasing its erosivity (Figure 8). As previously

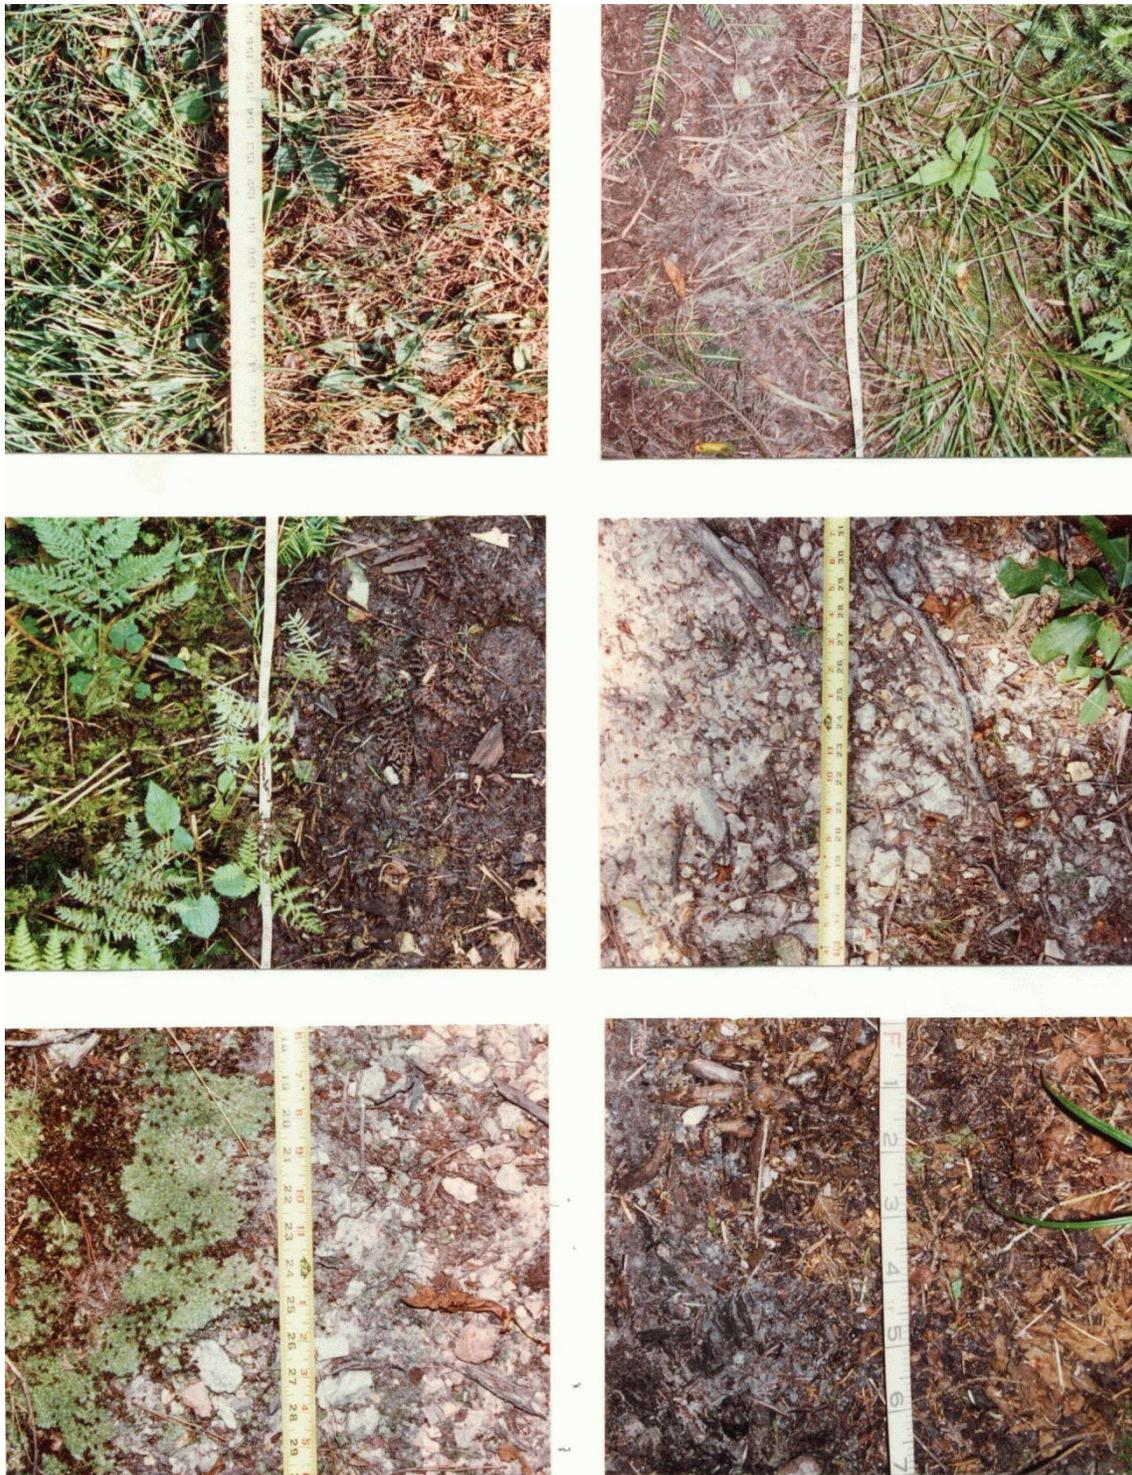
**Figure 1.** Photographs illustrating different types of boundary determinations. Trail tread boundaries are defined as the most pronounced outer boundary of visually obvious human disturbance created by trail use (not trail maintenance like vegetation clearing). These boundaries are defined as pronounced changes in ground vegetation height (trampled vs. untrampled), cover, composition, or, when vegetation cover is reduced or absent, as pronounced changes in organic litter (intact vs. pulverized). The objective is to define the trail tread that receives the majority (>80%) of traffic, selecting the most visually obvious boundary that can be most consistently identified by you and future trail surveyors.

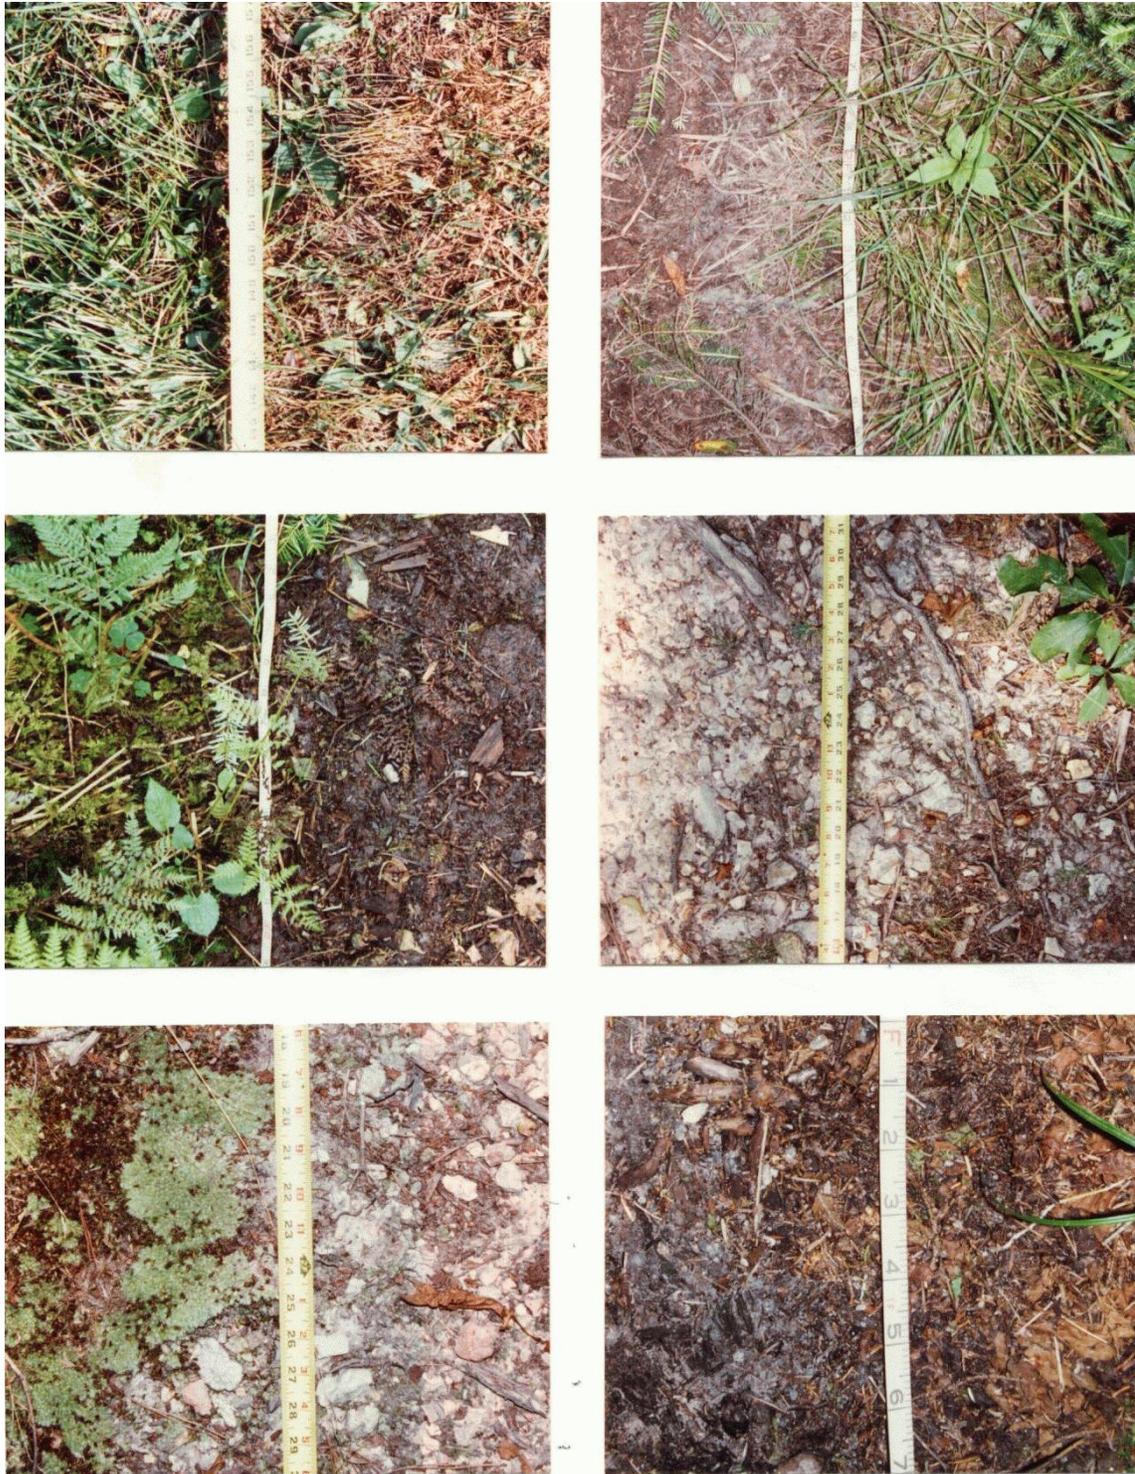
Figure 1. Trail width is defined as the most visually obvious outer boundary of trampling-related disturbance that receives the majority (>95%) of traffic. These boundaries are defined by pronounced changes in ground vegetation height (trampled vs. untrampled), cover, composition, or, when vegetation cover is reduced or absent, by disturbance to organic litter (intact vs. pulverized) or lichen.

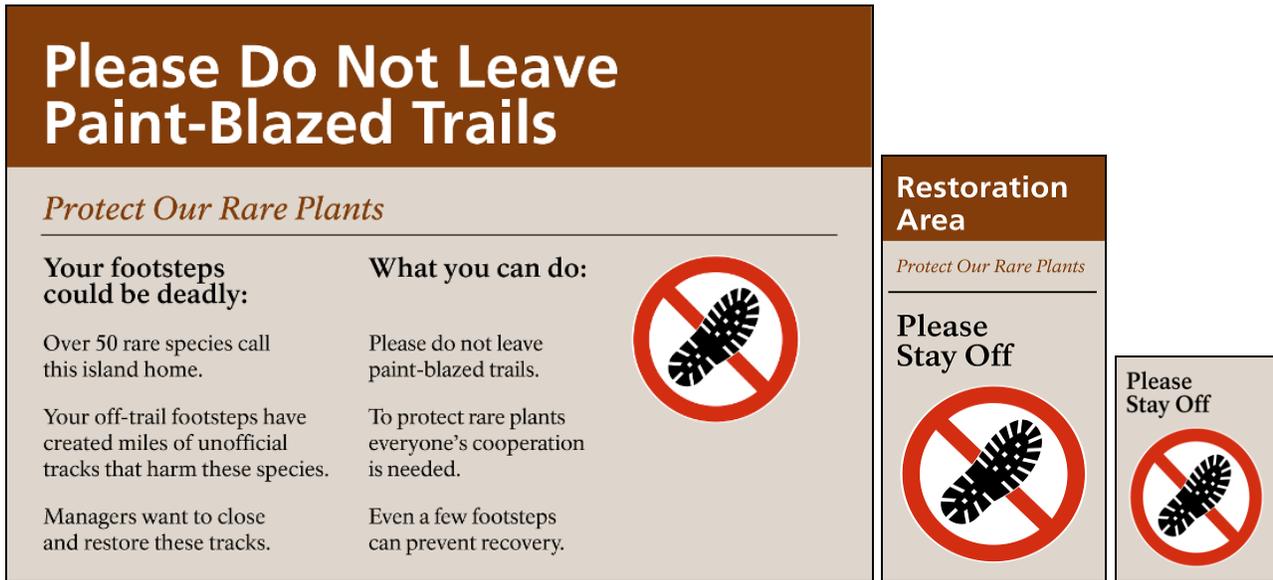
Figure 1. Examples of informative trailhead sign (left) and trailside prompter signs that can assist management efforts in closing informal trails.

A variety of site management actions are available for closing informal trails. Close lightly used trails by actions that naturalize and hide their tread disturbance, particularly along initial visible sections where visitors make the decision to venture down them. Effective actions include raking organic debris such as leaves onto the tread, along with randomly placed local rocks, gravel, and woody debris designed to naturalize and hide the tread. These actions also lessen soil erosion and speed natural recovery. On trails that have been effectively closed, transplanting plugs of vegetation at the beginning of wet seasons can hasten natural recovery. Revegetation work conducted before successful closure is achieved can be a frustrating waste of time and materials if visitors continue use of the trail and trample the transplanted vegetation.

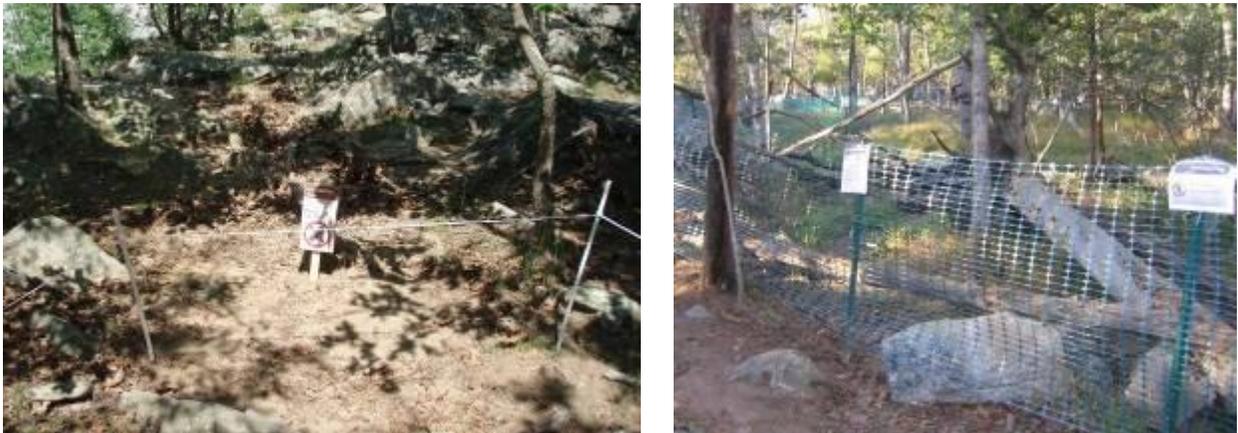
Figure 2. Low symbolic post and rope fencing (left) and high fencing designed to physically obstruct access (right).

For well-used trails, such work generally cannot fully disguise the disturbed substrates and vegetation so additional measures are necessary for effective closures. Construct a visually obvious border along the main trail, such as a row of rocks or a log, to communicate an implied blockage for those seeking to access the closed trail. Alternately, embed large rocks or place large woody materials or fencing to obstruct access at the entrance to closed trails to fully clarify management intent. Even temporary 2 ft tall post and cord symbolic fences can communicate the importance of closures and effectively deter traffic (Figure 2) (Park *et al.* 2006). Taller plastic fencing (preferably in green or brown) is also easy to transport and install to discourage traffic on trails that prove more difficult to close. However, fencing is generally perceived as visually obtrusive and inappropriate in more primitive settings.
